CSA 7 - Water System Feasibility Study and Seismic Retrofit Project Water System Improvement Recommendation Report

Prepared For:
COUNTY OF SAN MATEO
PUBLIC WORKS DEPARTMENT
Project # 12-075, October 2015

Water System Improvement Recommendation Report

Date: October 12th, 2015
Prepared by: Jigar Shah, PE
Anthony Baltazar, EIT
Tim Lewis, EIT
Checked by: Mike Fisher, PE

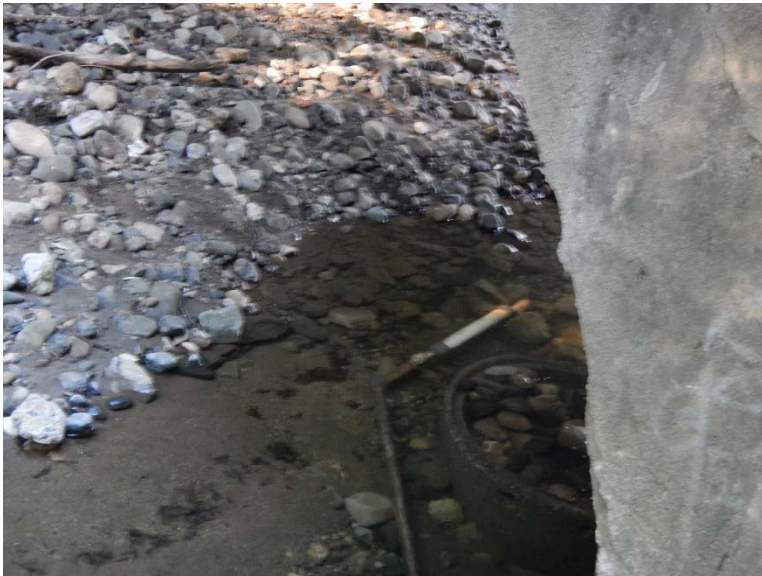
Figure 3: Suction Piping in Alpine Creek

Raw water is currently diverted from Alpine Creek near Pescadero Creek Road Bridge over 1,800 LF of 2½ -inch GSP into a 70,000-gallon raw water tank. The intake piping consists of 2-inch diameter GSP with a well screen at the end of the suction side of the piping submerged in the creek. The intake pipe is connected to the inlet side of a (1) 7.5 HP pump. Figure 3 shows the suction piping in Alpine Creek. The County has observed that the turbidity of the raw water increases during the heavy rainfall events, and is not effectively treated by the WTP during such events.

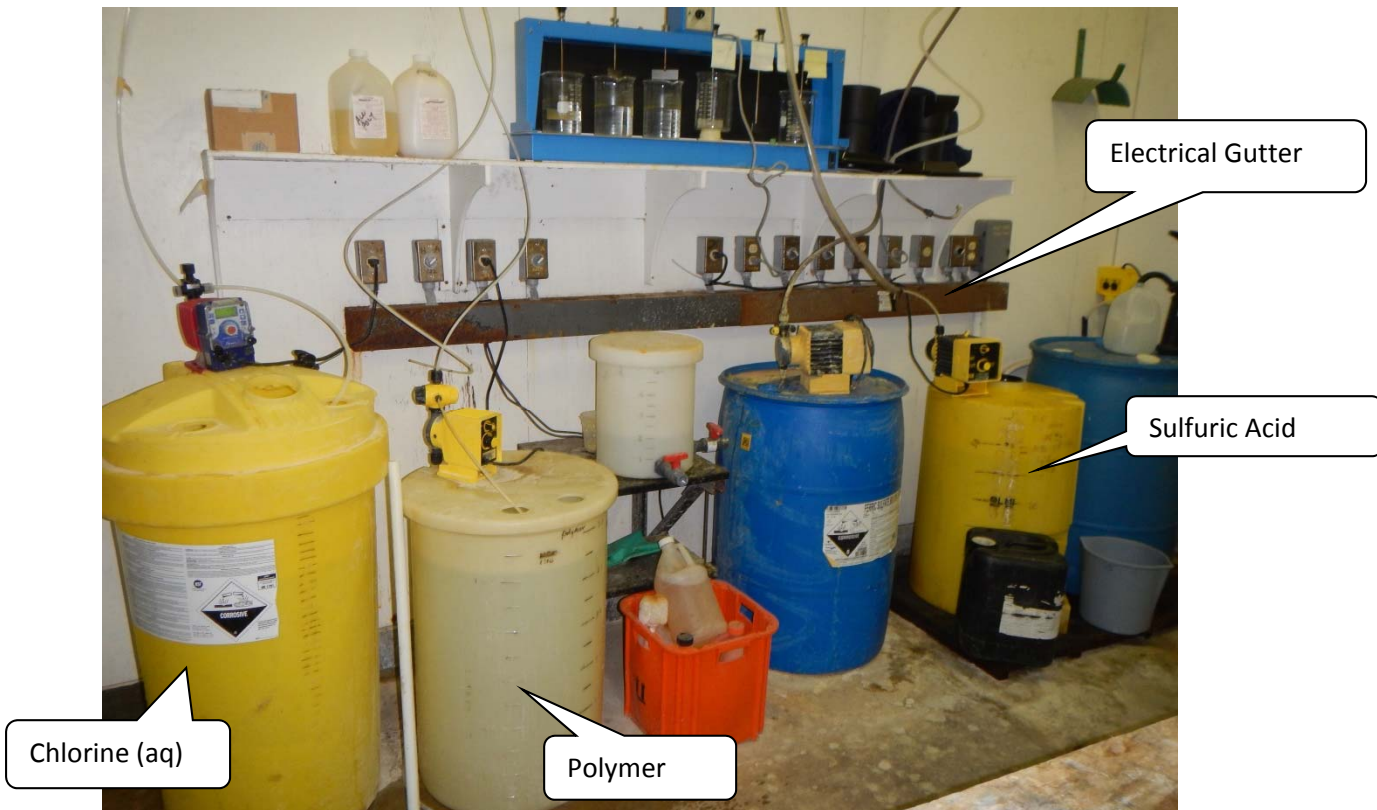
Figure 5: Chemical Containment & Electrical Gutter

The County uses three primary chemicals at the WTP. Liquid chlorine is used for disinfection, sulfuric acid for pH adjustment, and polymer for flocculation. The liquid chlorine is stored in a 45-gallon drum, sulfuric acid in a 35-gallon drum and polymer in a 30-gallon drum. These chemicals are refilled weekly with a 5-gallon utility bucket. The three chemical drums do not have secondary spill containment and are not anchored down. In addition, the peristaltic pumps rest on top of the chemical drums and are not secured. WWE also observed surface corrosion and deterioration of the steel electrical wiring gutter located behind the chemical storage and pumping area. Figure 5 shows the chemical storage tanks and electrical gutter.

WWE observed extensive corrosion to the electrical gutter, receptacles, and switches behind the chemical containers. Replacement of the existing gutters and receptacles is needed, whereas the existing conduits are in fair condition and do not require immediate replacement. Waterproof Ground Fault Circuit Interrupter (GFCI) receptacles should be used and NEMA 4X pull boxes where needed. Covers should be waterproof and made out of a thermoplastic material.

The recommended chemical containment for the chemical drums will be similar to Brady SPC Absorbents Spill containment pallet made of HDPE material. The containment size is 17”H x 26”W x 52”L providing up to 68-gallon capacity, which is double the volume of the chemical containers. Figure 10 shows the spill containment pallet for chemical containment. A seismic stainless steel strap similar to a household water heater strap should be used to anchor the chemical drums to the WTP wall.

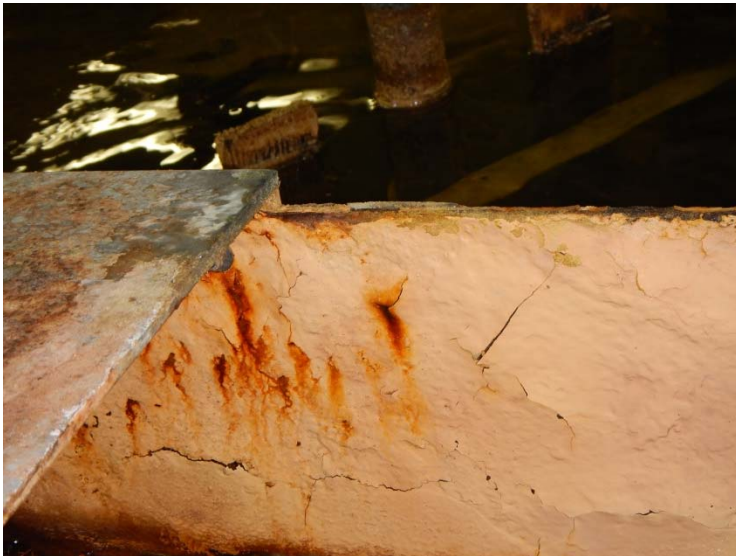
Figure 6: Flocculation Chamber Corrosion Resistant Paint

During a January 23, 2015 site visit, WWE observed that the corrosion resistant coating in the WTP flocculation chamber was cracking and chipping off. These cracks in the paint are shown in Figure 6.

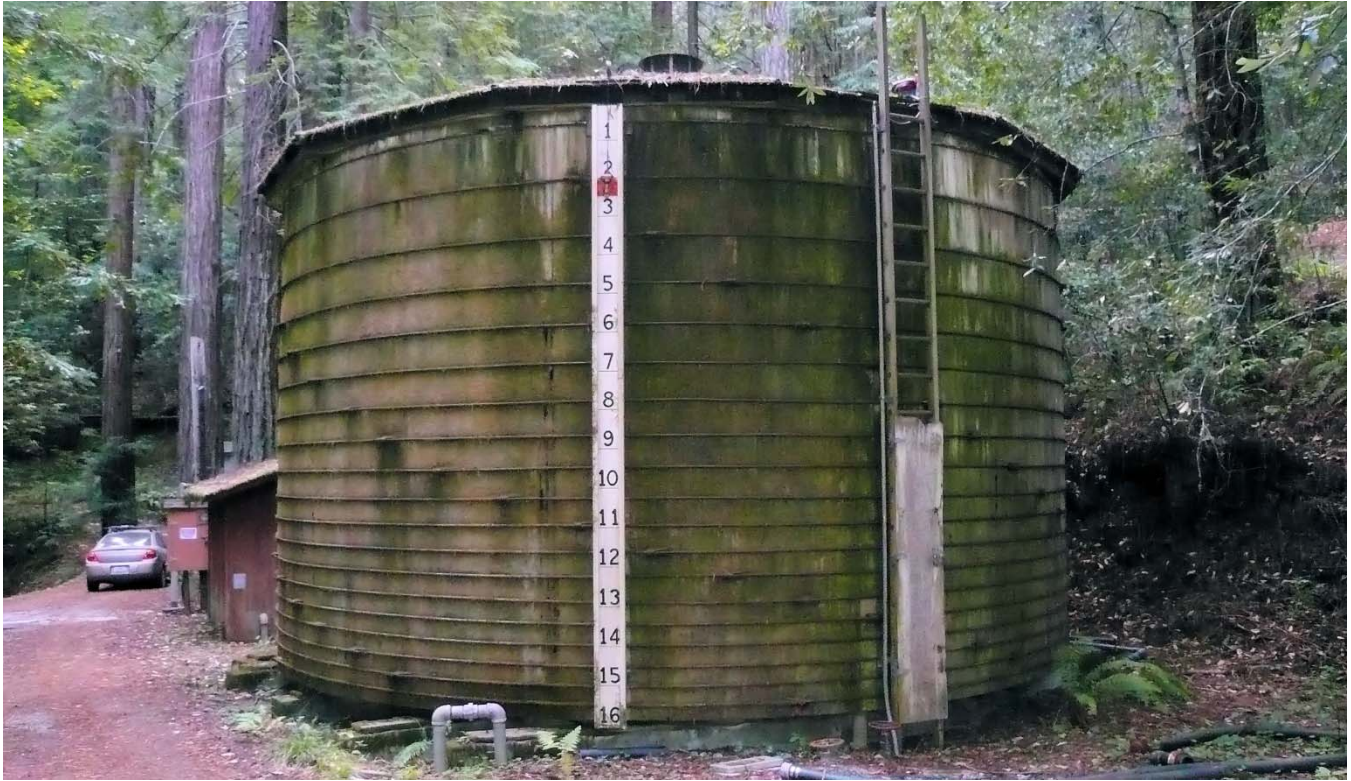
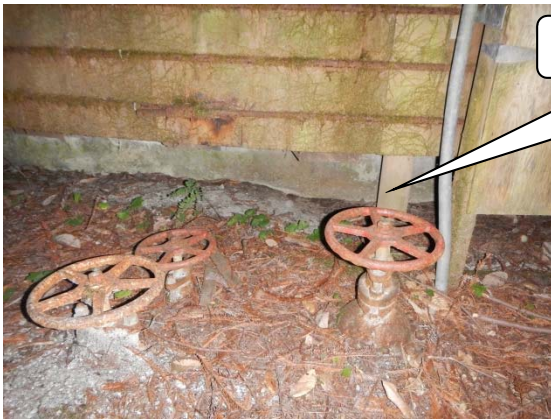
Figure 7: Raw Water Redwood Tank & Inlet/Outlet Pipe Connection

WWE and LiquiVision Technology Diving Services conducted underwater inspection of the redwood tank on October 24, 2014. The standards used to evaluate the condition of the redwood and steel tanks include Standard Method of Evaluating Degree of Rusting on Painted Steel Surfaces – SSPC-Vis 2-82, ASTM D 610-85 NACE Standard RP0196-96 & RP0388-2001 and Condition of Concrete In-service – ACI 201.1R-92. The redwood tank inspection noted the roof, ceiling and interior ladder are in extensive deteriorating condition. The redwood tank floor and its walls are in moderately deteriorating condition.

WWE conducted a thorough site inspection on November 12, 2014 and performed a structural evaluation of the redwood tank. A technical memorandum summarizing the evaluation was prepared and is included in Appendix B.

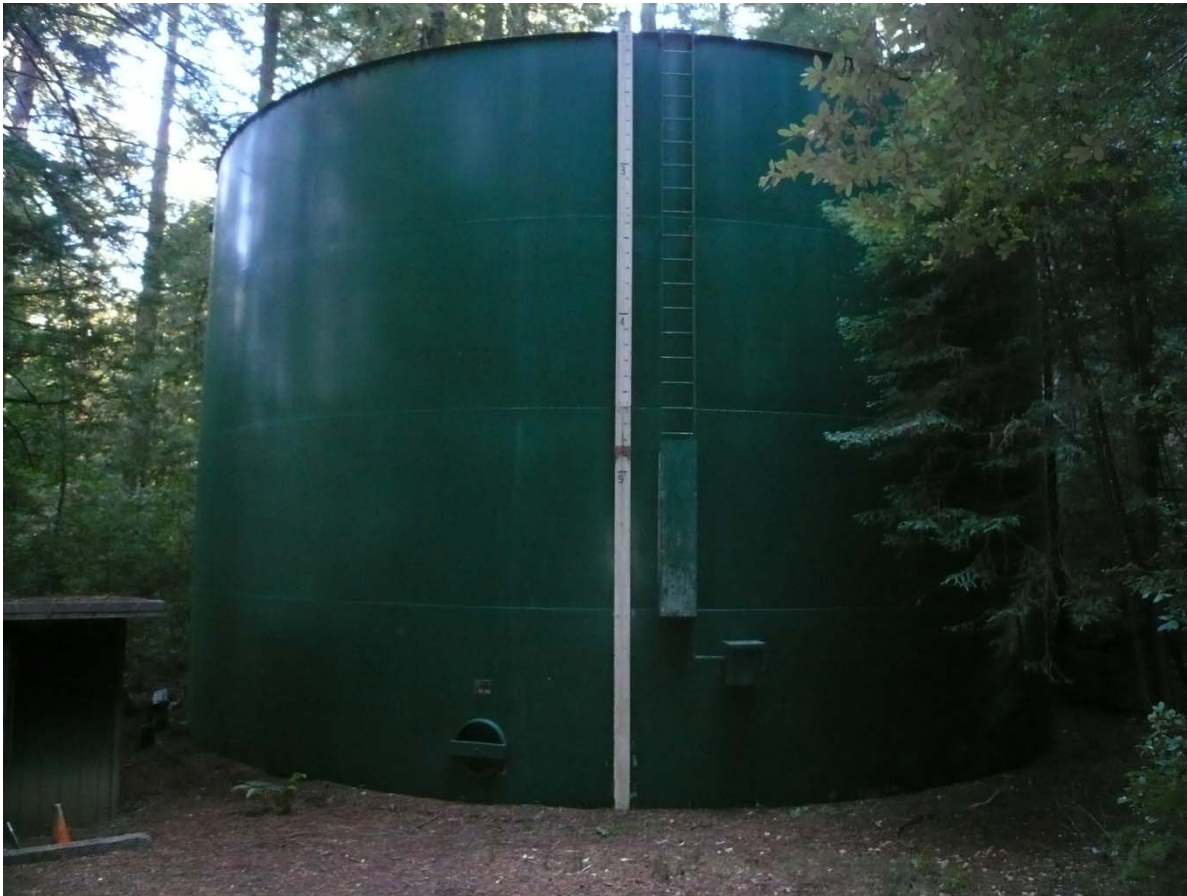
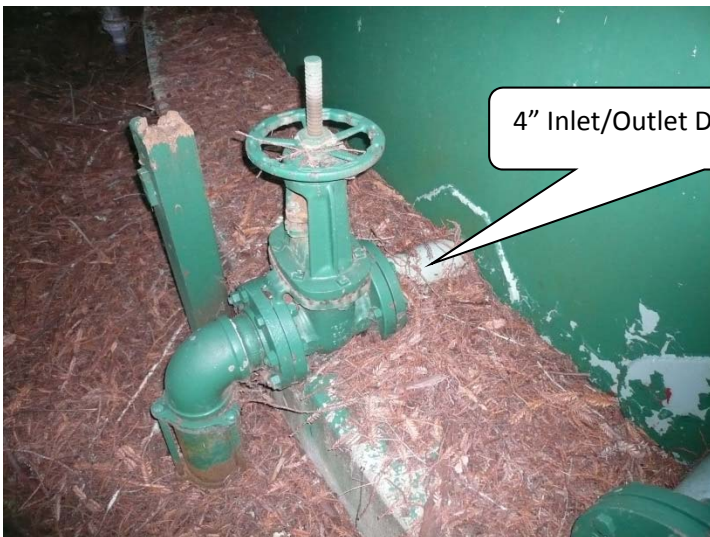
Figure 8: Treated Water Tank & Inlet/Outlet Pipe Connection

The existing 500,000-gallon Steel tank was constructed in 1967. The tank is sitting on a concrete ring foundation with a sand base. Based on the Master Plan, the tank bottom lip sits about 2 inches below the top of the concrete ring. There is an asphalt seal over the sand around the tank base. The ratio of tank diameter to height indicates it is unlikely that the tank will overturn in a major earthquake. Recently the tank had been coated externally. WWE observed the tank to be in good condition during the January 23rd, 2015 site visit. The treated water tank and inlet/outlet pipe connection is displayed in Figure 8.

WWE and LiquiVision Technology Diving Services conducted underwater inspection of the steel tank on October 25, 2014. The steel tank inspection noted that the coal tar coating on the interior wall, ceiling and floor appear to be in a good condition with minor deterioration. The steel tank overflow and 4-inch capped off penetration appear to be in fair condition with minor deterioration.

The 4-inch inlet/outlet ductile iron pipe (DIP) connection is located at the base of the Steel tank. It consists of a 4" Gate Valve (GV), a 90-degree elbow turning down, a flexible coupling connecting to the existing 4-inch pipe in the ground. WWE inspected the inlet/outlet piping connection on January 23, 2015, and found it does not have any seismic-resistant connections. The connection details are described in Section 2.

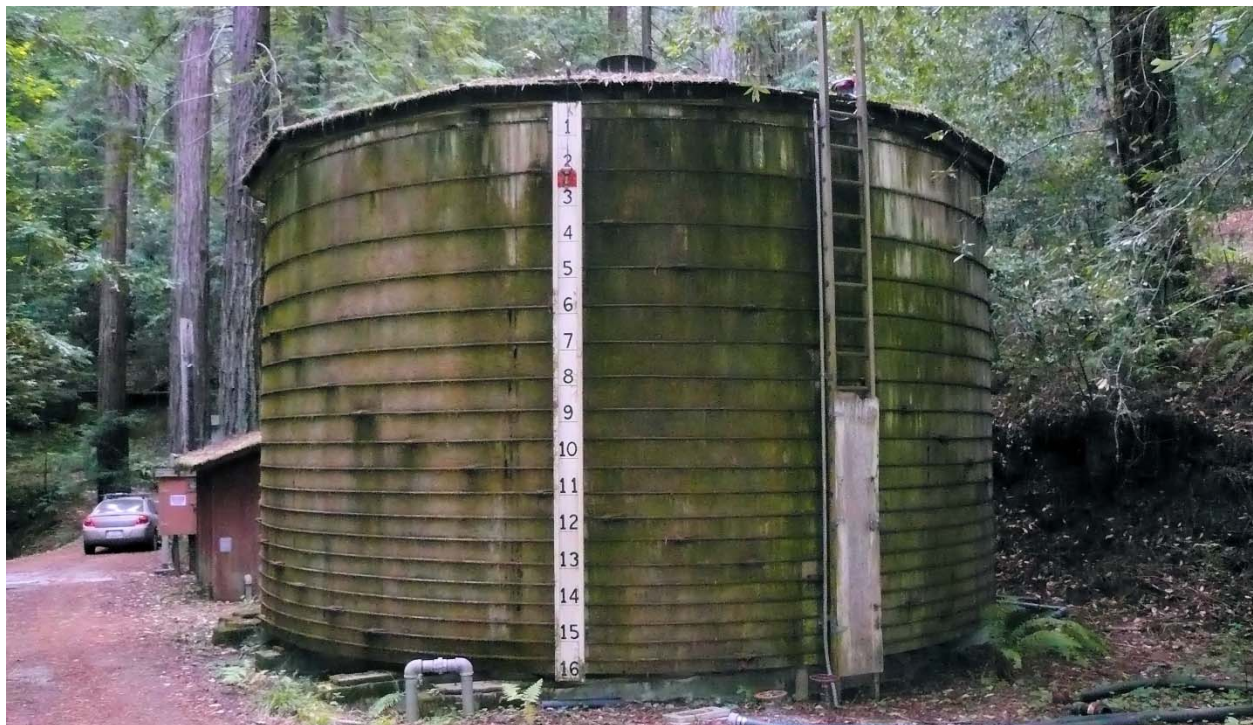
Figure 1 70,000 Gallon Redwood Water Storage Tank

Based on the seismic analysis required by ASCE 7-10 the tank is subject to multiple insufficiencies when subjected to an earthquake. The tank is lacking anchorage, sliding resistance, roof to wall shear transfer, and insufficient freeboard, at a minimum. It was also determined that the existing roof is in poor condition and has likely exceeded its useful life and is in need of replacement.

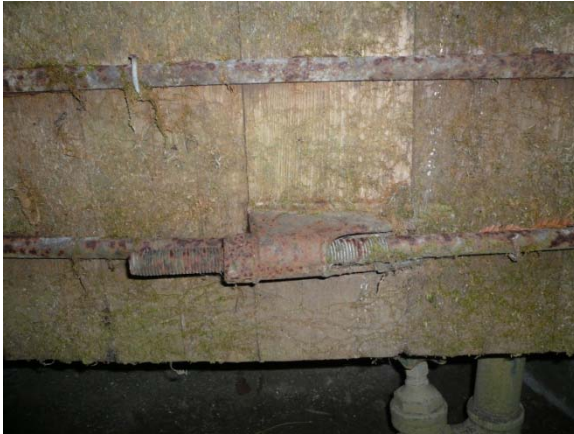
Figure 2 Circumferential Cable Corrosion

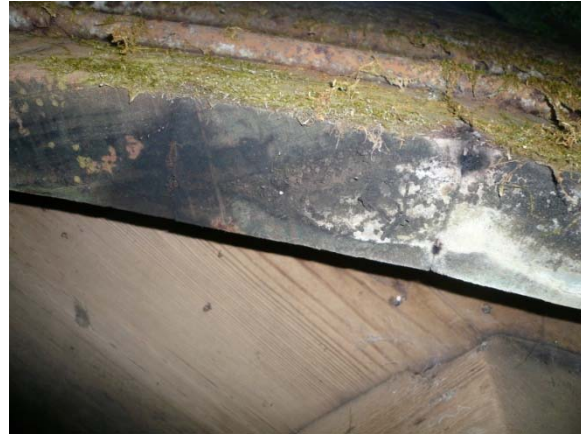
Figure 3 Bottom of Vertical Stave

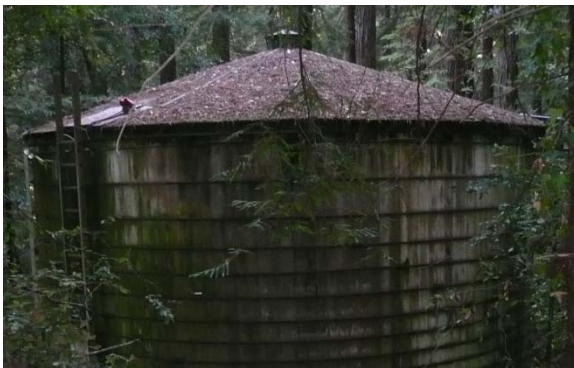
Figure 4 Tank Roof

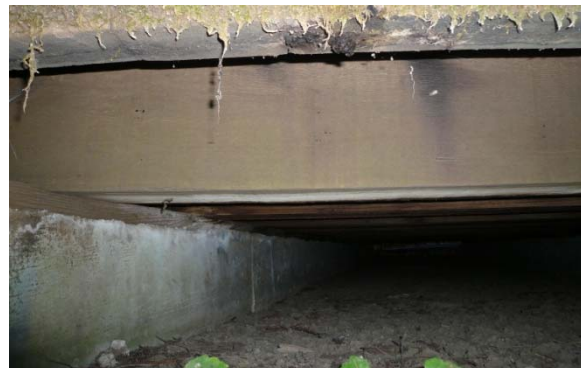
Figure 5 Joists and Grade Beam
