Biological Resources Assessment

SAN MATEO COUNTY QUARRY PARK MASTER PLAN PROJECT EL GRANADA, SAN MATEO COUNTY, CALIFORNIA

APPENDIX B | WATERSHED ASSESSMENT AND EROSION PREVENTION PLAN

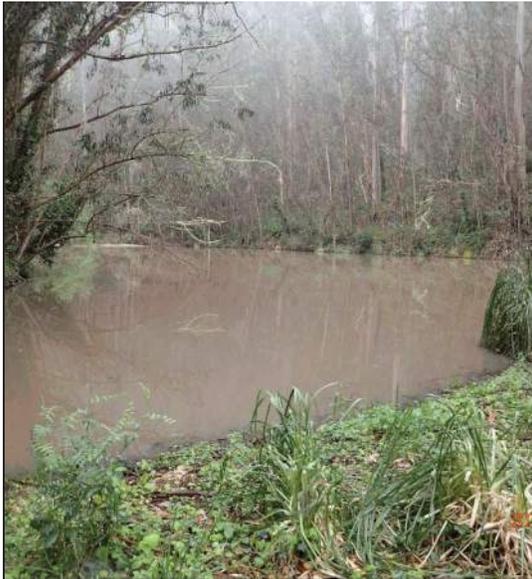
Photo 1. Photograph of large pond located within the eastern portion of the blue gum grove.

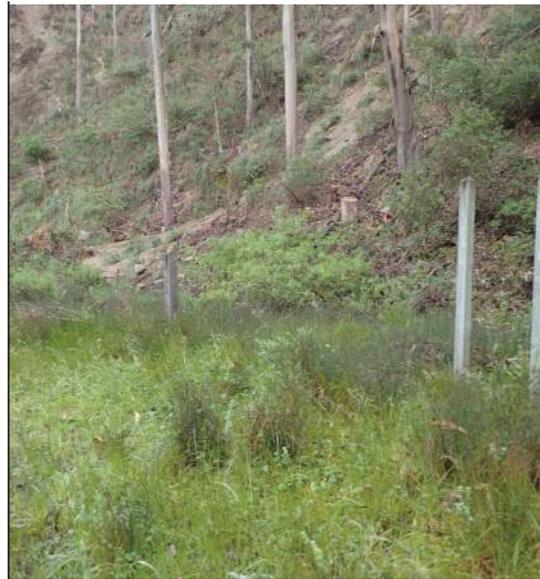
Photo 2. Photograph of a potential seasonal wetland located within non-native annual grassland at excavated clearing in the blue gum forest.

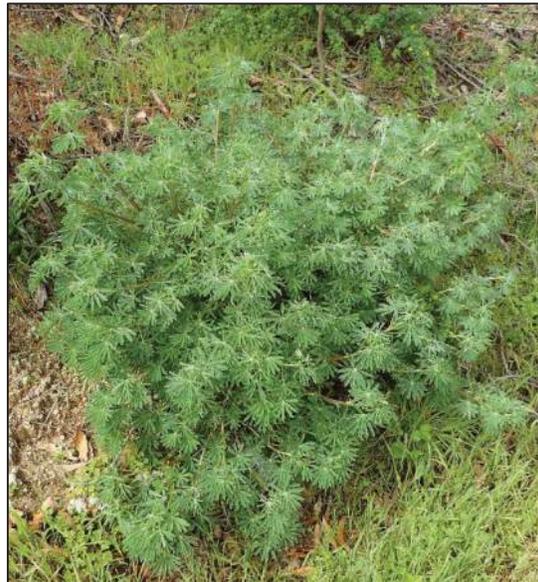
Photo 7. Unidentifiable shubby lupine species that has potential to be San Mateo tree lupine, observed adjacent to northern coastal scrub habitat.

An unknown, shrubby species of lupine was observed in the Study Area that has vegetative characteristics consistent with both San Mateo tree lupine and silver lupine (*Lupinus albifrons*), a common native species. The observed lupine shrubs were not flowering at the time of the March 2017 site visit and were therefore not identifiable to species. The shrubby lupine was observed along margins of the northern coastal scrub within the Study Area. Given the presence of coastal scrub vegetation, there is high potential that some of the shrubby lupines observed in the Study Area may be San Mateo tree lupine.

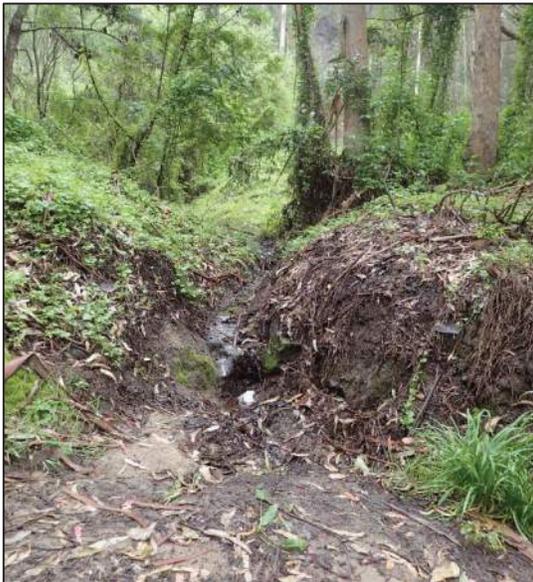
Photo 9. Photo of ephemeral stream within the blue gum grove.

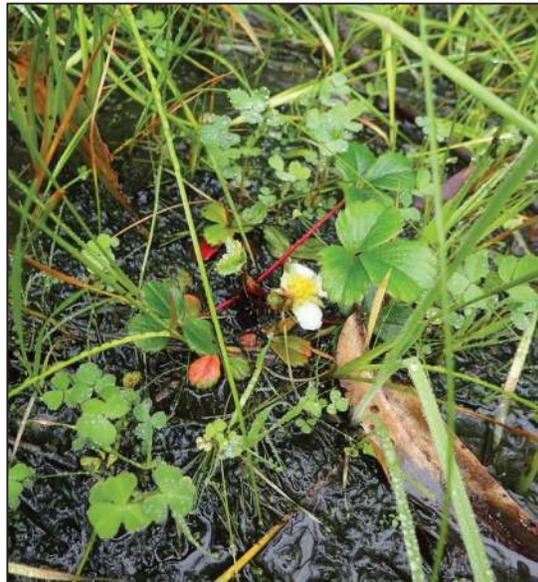
Photo 10. Photo of woodland strawberry (*Fragaria vesca*) found in the understory of the blue gum groves.

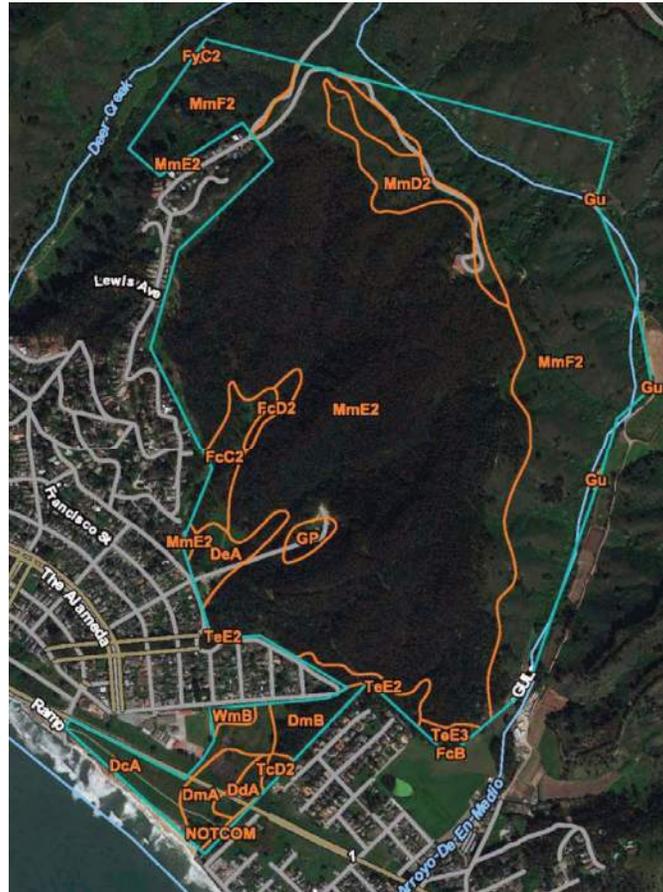
Figure 1. Soils within Quarry Park Property according to NRCS Websoil Survey.

K factors for the Universal Soil Loss Equation (USLE) determined by the National Cooperative Soil Survey (USDA NRCS, 2013) range from 0.15 for the Miramar complex soils to 0.32 for the Tierra complex soils. The higher K factors indicate more potential for erosion.

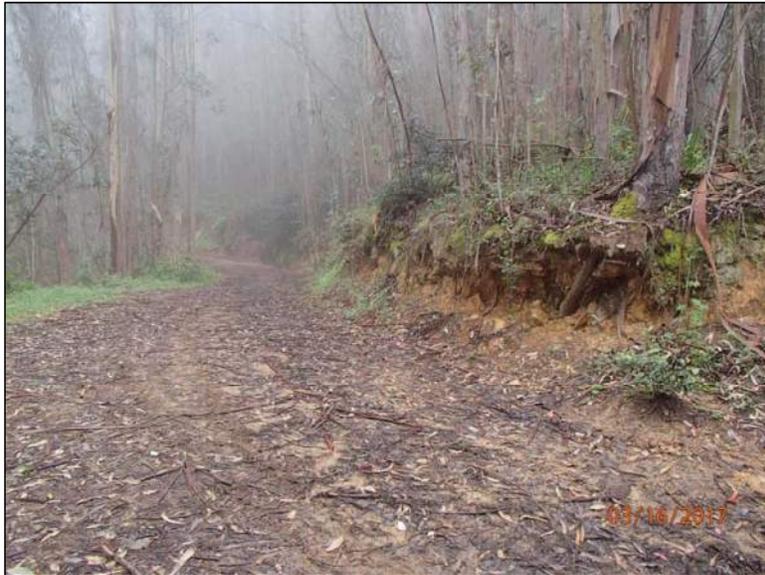
Photo 1 (Dolphine Fire Road): View of the existing road conditions of the native surfaced Dolphine Fire Road near the road intersection with the Middle Ridge Fire Road.

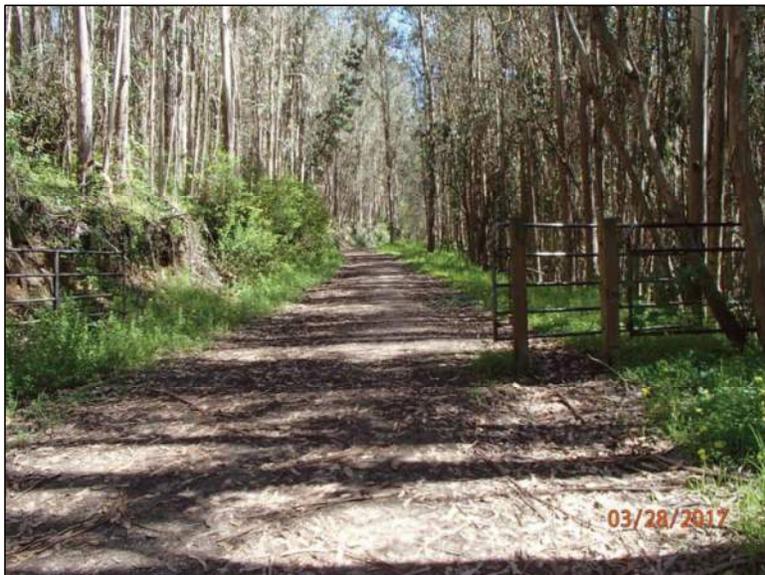
Photo 2 (Miranda East Fire Road): View of the existing road conditions on the Miranda East Fire Road at Gate 4 as shown on Map 2.

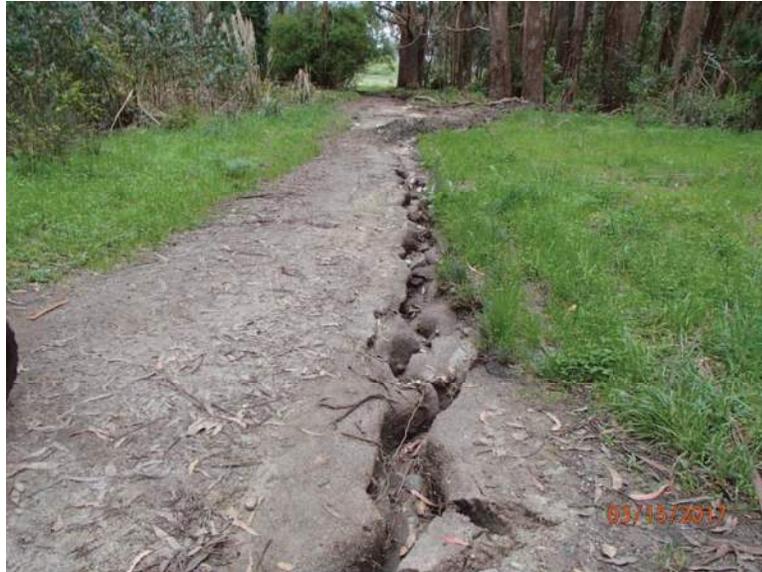
Photo 3 (Meadow Trail): View of active gully erosion along the Meadow trail. Combined diverted stream flow and concentrated road runoff are eroding the road surface along this native surfaced road.

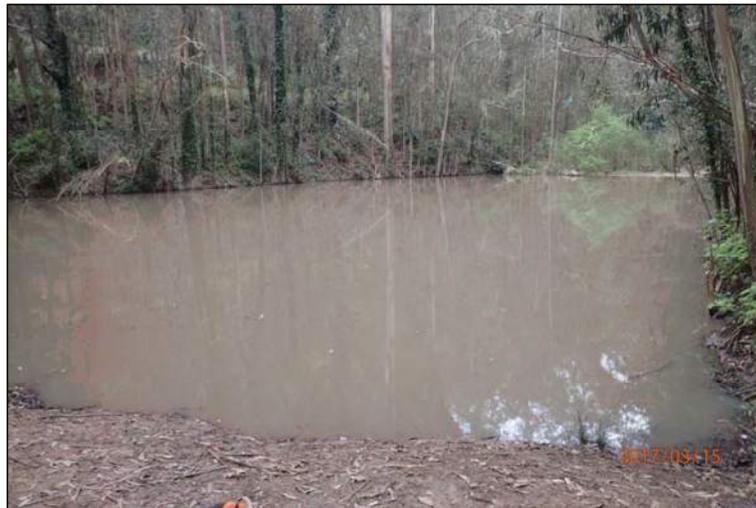
Photo 4 (Site #4): View of the on-stream pond located at Site #4 looking upstream from the left edge of the levee. Note the aggraded sediment at the upstream edge of the pond.

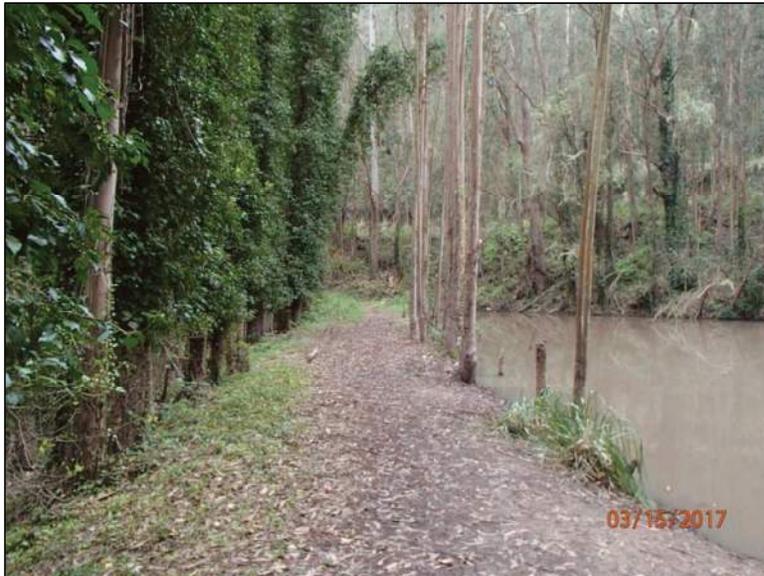
Photo 5 (Site #4): View of the levee associated with the on-stream reservoir Site #4, looking west-southwest across the top of the dam face.

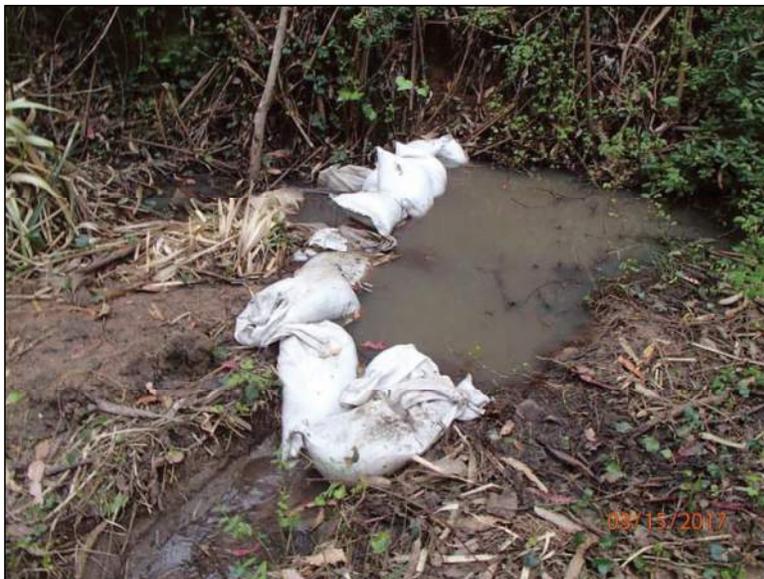
Photo 6 (Site #4): View of temporary dysfunctional sandbag spillway at the southwest corner of the on-stream pond Site #4.

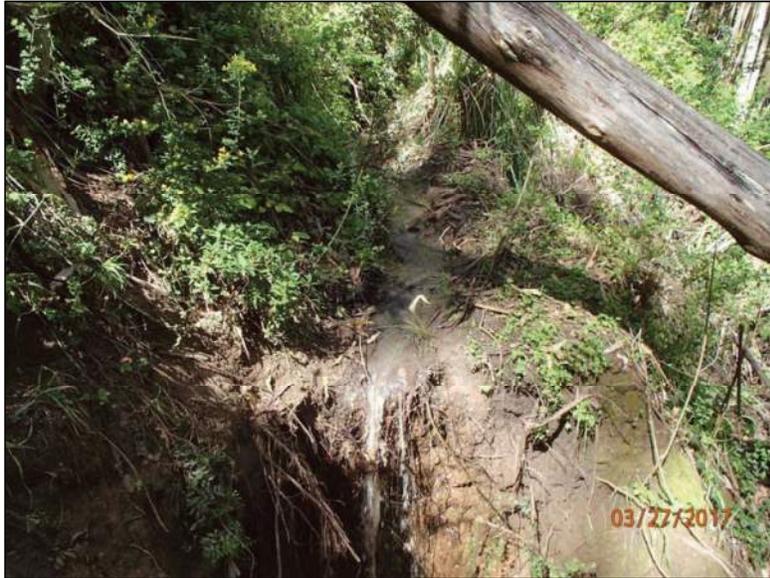
Photo 7 (Site #4): View of a road fill failure caused by diverted pond outflow. This erosion feature is located down the right road from the levee. Note the road prism is completely washed out.

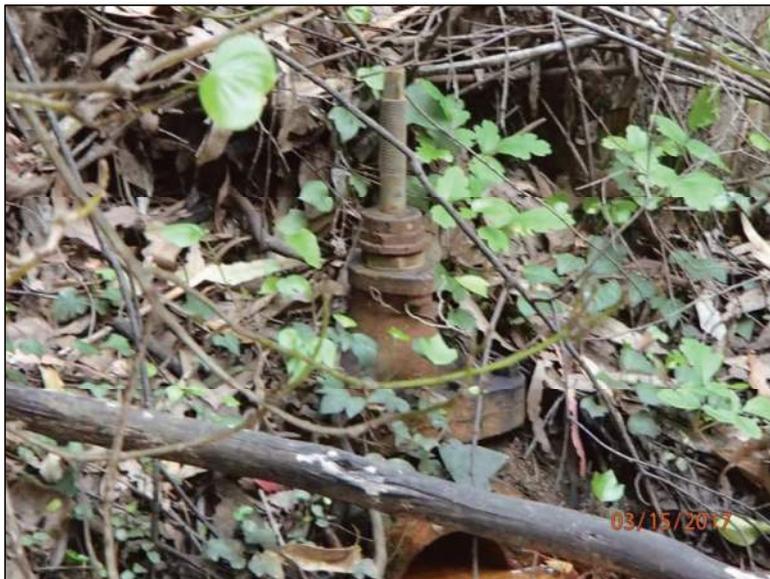
Photo 8 (Site #4): View of the seeping drainage valve at base of the dam fillslope in the axis of the valley downstream of pond.

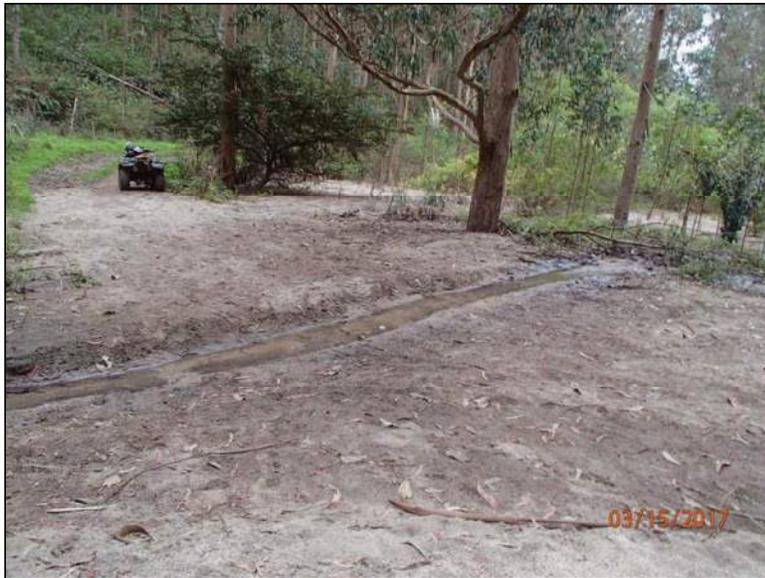
Photo 9 (Site #2): View of stream crossing through this shallow sediment filled pond. Stream sediment transport has deposited a large volume of fine sediment in this old pond, inundating the pond and trail.

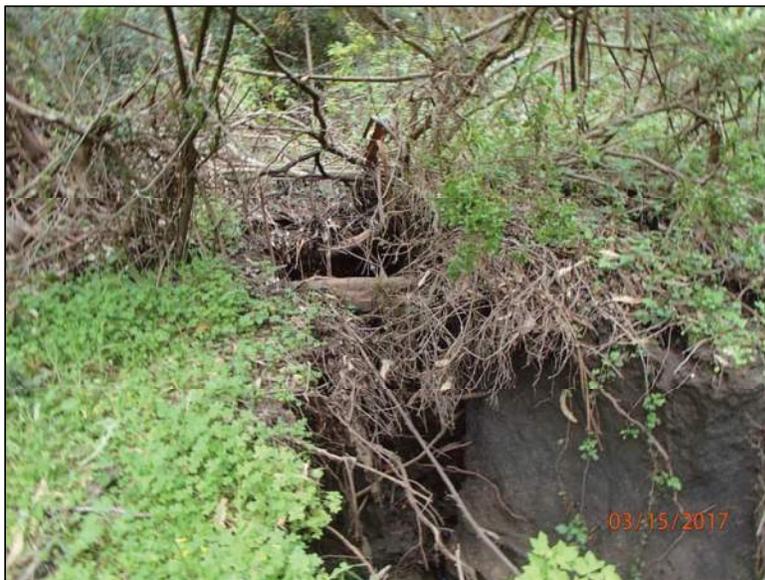
Photo 10 (Site #2): View of an active 5.5ft tall headcut at the downstream extent of the inundated pond at stream crossing Site #2 on the Meadow trail shown in the previous photo.

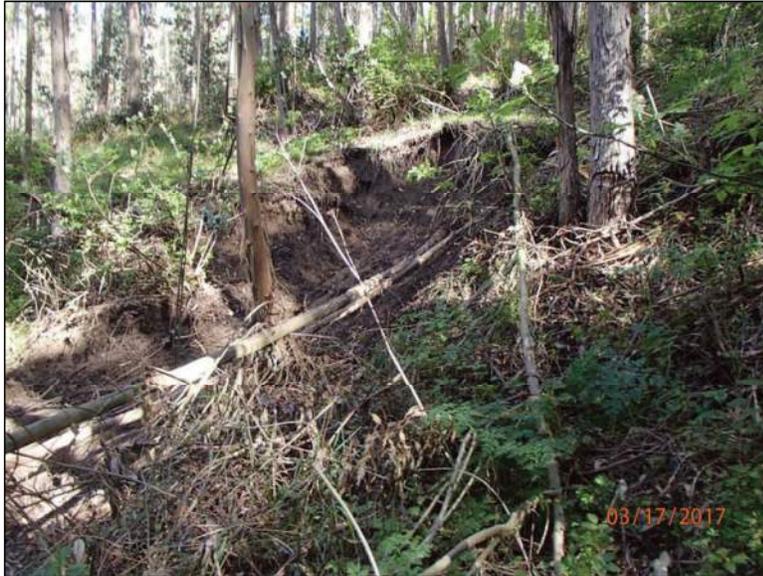
Photo 11 (Site #19): View of failing cutbank immediately upslope of the right edge of stream crossing Site #19. This cutbank failure delivers directly to the Class III stream in the axis of the crossing fill crossing.

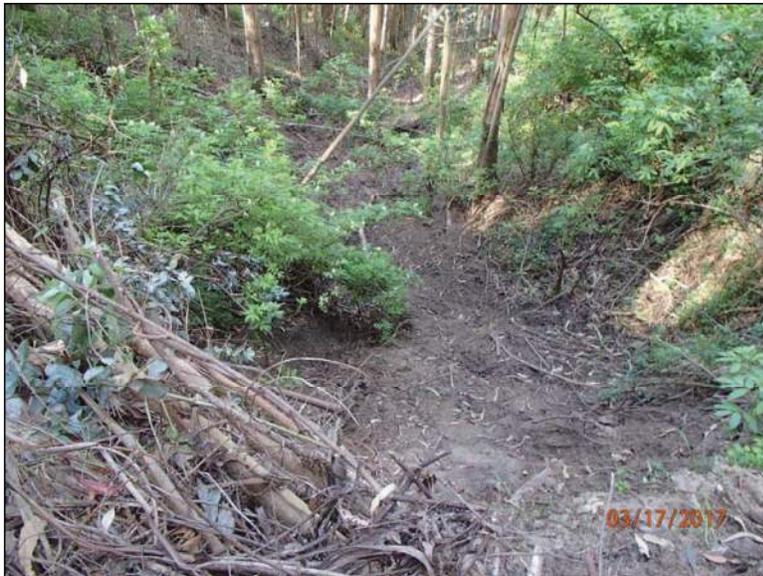
Photo 12 (Site #19): View of failing outboard fillslope, looking downslope at the fill failure deposits below the right hingeline of the fill crossing at Site #19. This photo was taken from the outboard edge of the road.

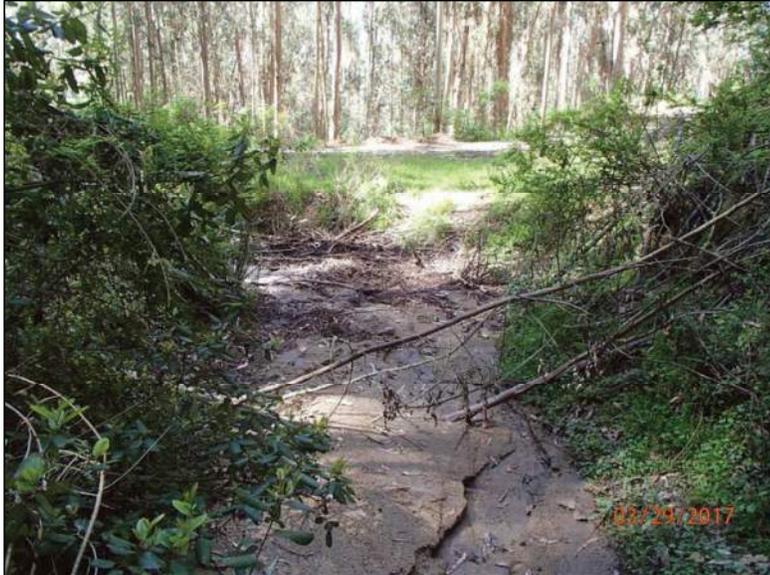
Photo 13 (Site #39): View looking downstream from the upstream extent of the of the failing stream crossing. Note the recently deposited sediments that have plugged the culvert inlets. The sediment is causing the stream flow to divert down the left road which is inducing a delivering fill failure.

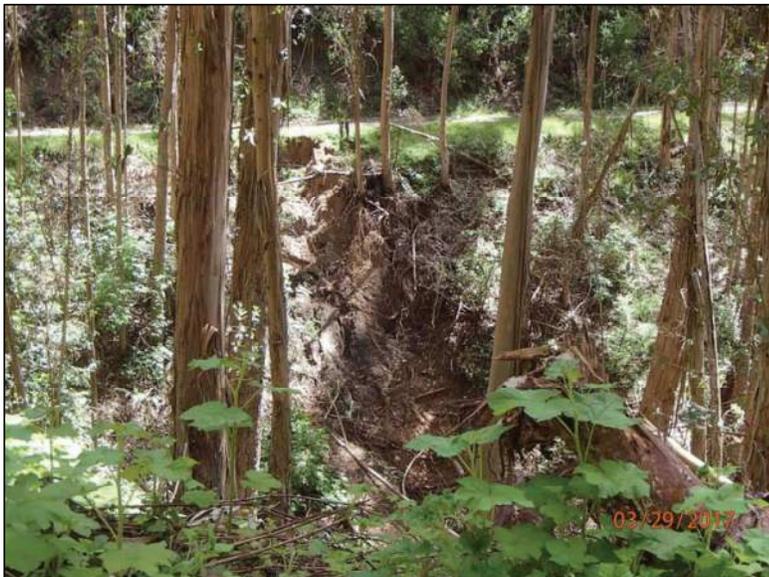
Photo 14 (Site #39): View of an outboard fill failure to the left of the stream crossing. The fill failure was induced by the diverted streamflow from the plugged stream crossing at Site #39 and excessive concentrated road surface runoff.

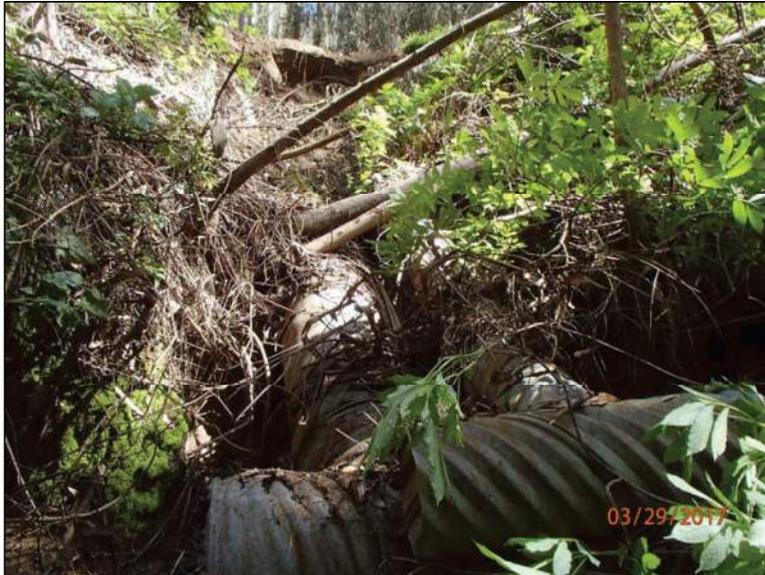
Photo 15 (Site #39): View looking upstream at the failing outboard fillslope of this plugged stream crossing. The photo was taken standing approximately 8ft downstream of the culvert outlets.

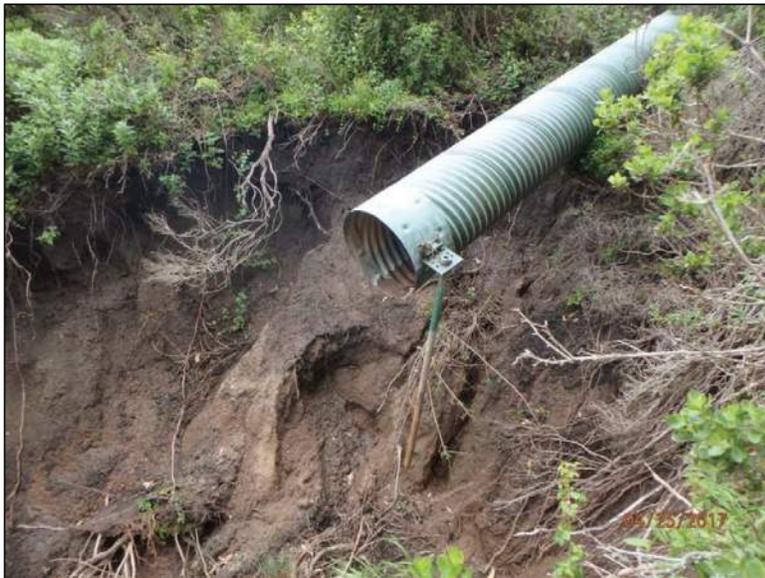
Photo 16 (Site #40): View of a section of disconnected culvert downspout at the top of an actively migrating headcut and gully below the paved Private Drive at Site #40. Oxidation exposed on the stake is indicative of the previous depth of burial prior to the episodic hillslope failure.

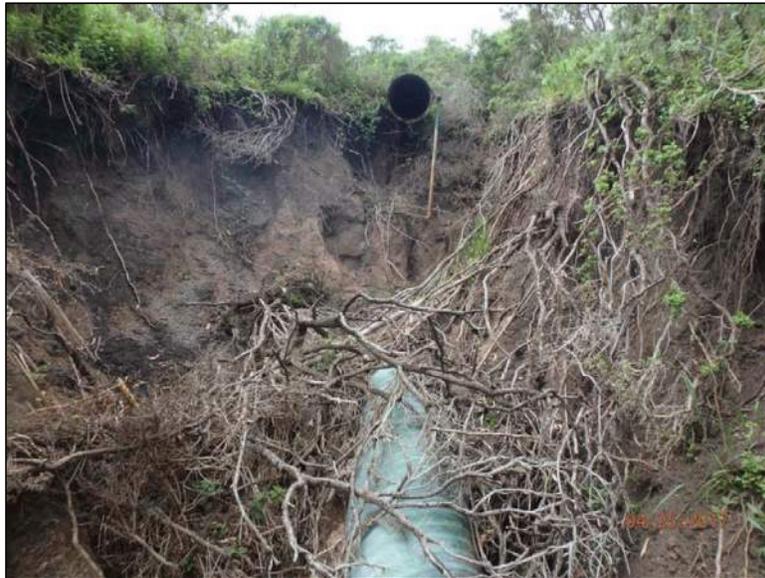
Photo 17 (Site #40): View looking upslope at the same disconnected downslope and active erosion as shown in the previous photo. The photo was taken from the base of the gully downslope of the headcut standing on top of one of the failed sections of culvert.

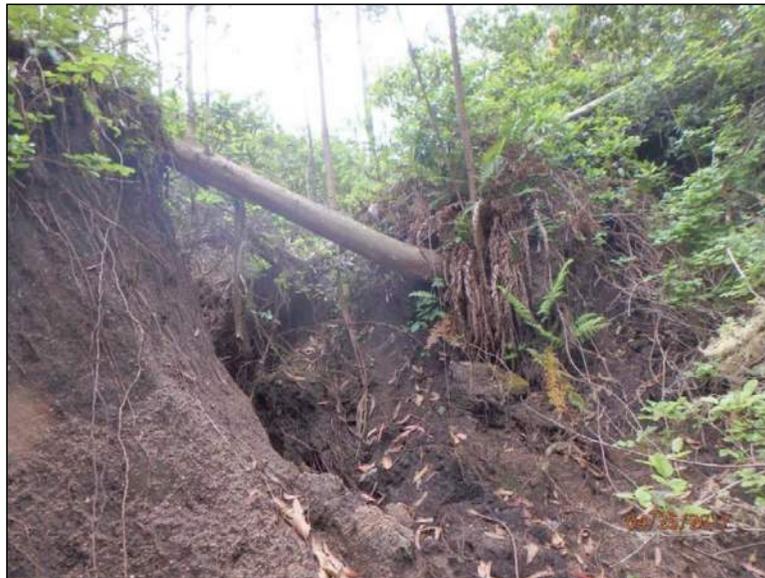
Photo 18 (Site #40): View of active hillslope gully below Site #40 looking upstream. This photo was taken from the edge of the tree-line near the headwaters of a small Class III stream that drains to Site #16 downstream. The gully is conveying sediment from the gully erosion upslope to the Class III stream.

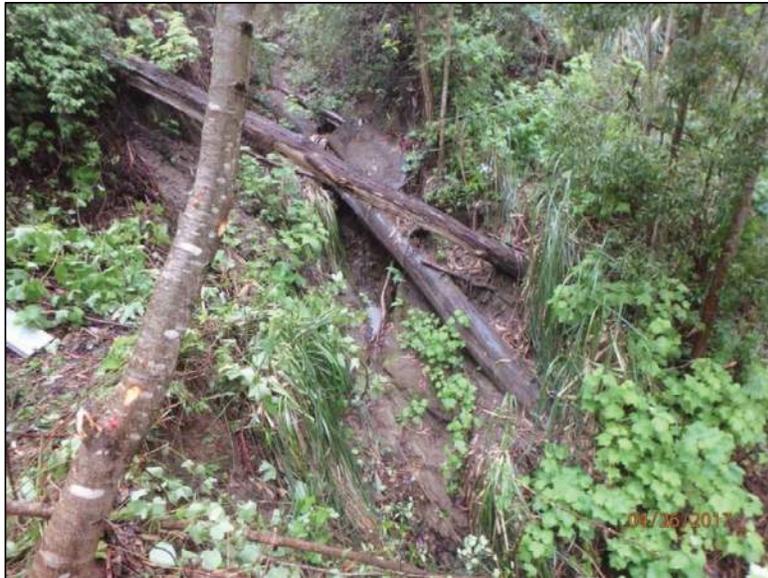
Photo 19 (Site #41): View looking upstream at a washed out fill crossing on a near origin Class III stream downslope from residential area on Santa Maria Avenue. This view of the scoured stream channel was taken from the outboard edge of road at Site #41.

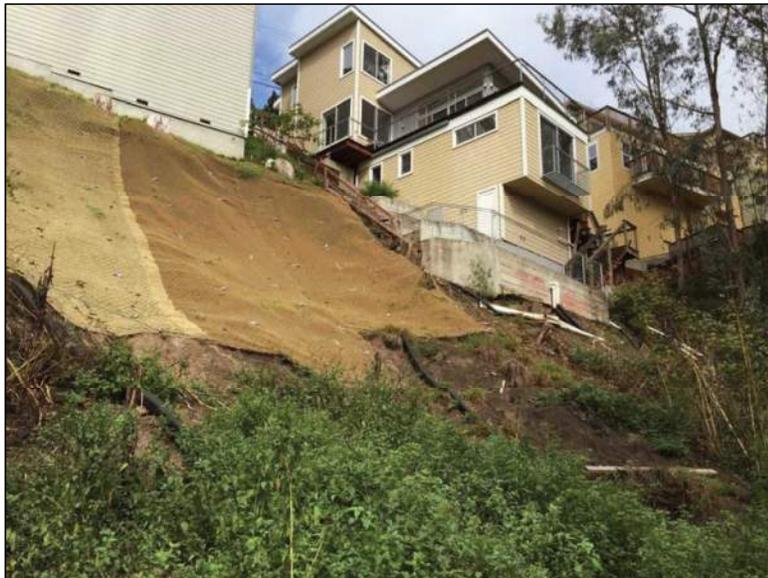
Photo 20 (Site #41): View of a hillslope failure and undermined residences upstream from Site #41. This area upslope extent of AOC 4 as discussed in the text of the report. This photo was taken from the outboard edge of the Fire Break Road upslope from the Upper Pond Legacy Road as shown on Map 2.

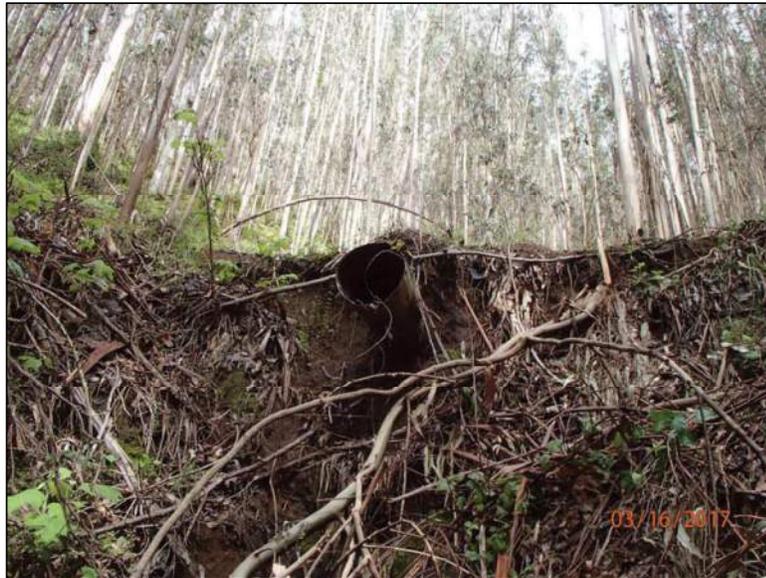
Photo 21 (Site #9): View of the perched culvert outlet at stream crossing Site #9. The culvert at this crossing is undersized and installed high and short in the fill with a 6ft drop at the outlet and subsequent outboard fill erosion.

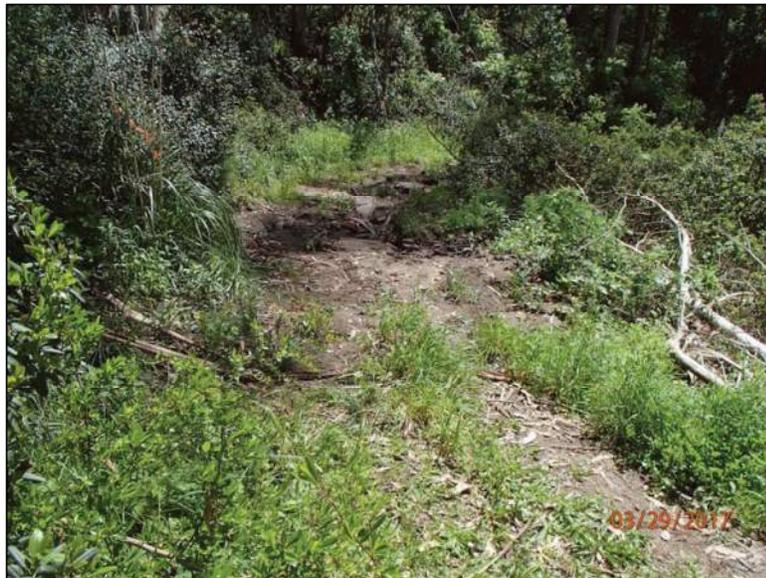
Photo 22 (Site #16): View of the fill crossing at Site #16 on the Dolphine Fire Road. Diverted stream flow is actively eroding gullies down the left road from this stream crossing.

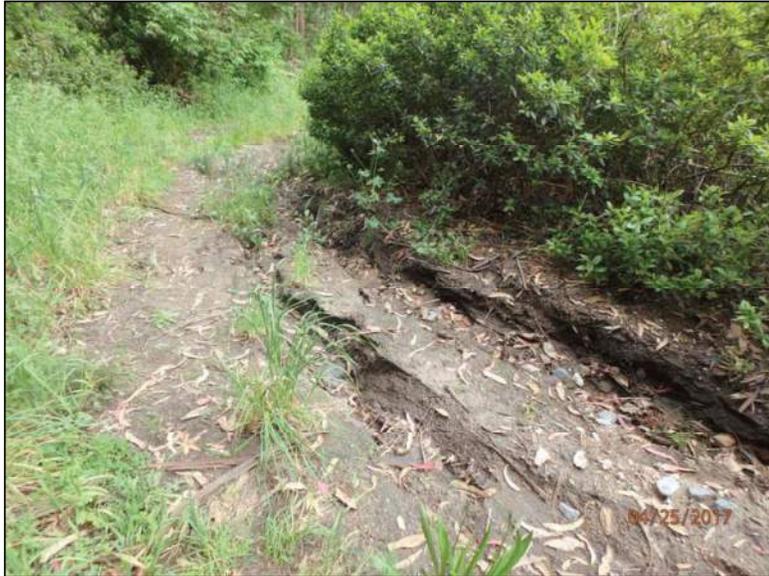
Photo 23 (Site #16): View of the left road approach to fill crossing Site #16. Diverted stream flow is actively eroding gullies down the left road from this stream crossing and delivering to a watercourse at Site #15.

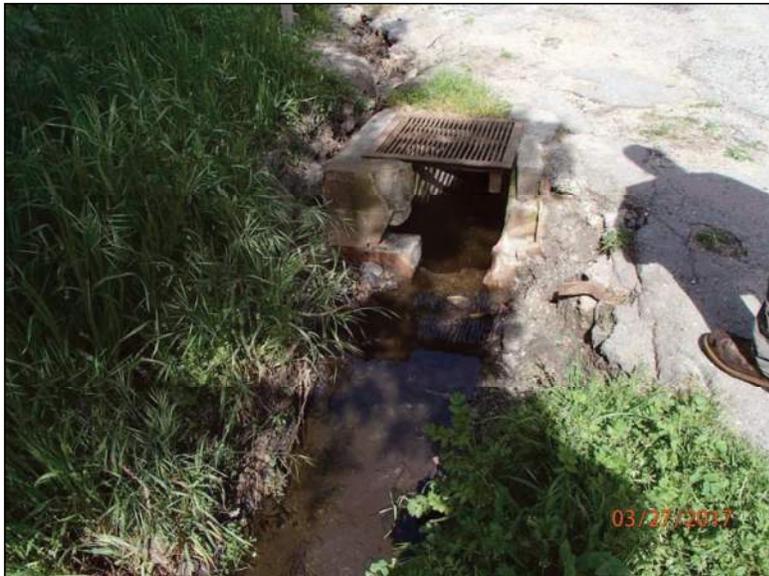
Photo 24 (Site #23): View of the outlet of the culvert at stream crossing Site #23 at the edge of the main parking lot. This culvert is undersized and stream flow avulses out of the drainage alignment and onto the parking lot surface.

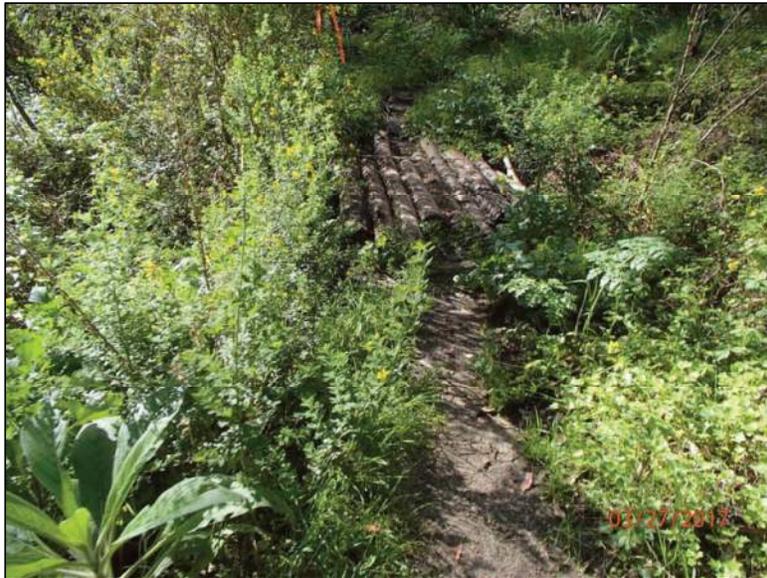
Photo 25 (Site #24): View of a makeshift foot bridge at stream crossing Site #24. The active erosion at this site is minimal, and a formal crossing should be established.

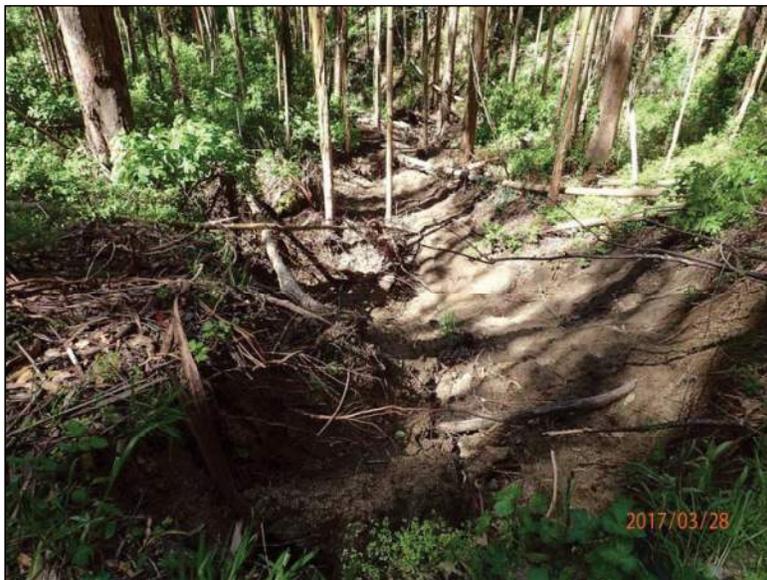
Photo 26 (Site #31): View of an outboard fill failure at Site #31 on the Vista Point Trail. Concentrated road run off had saturated the steep outboard fill and subsequently destabilized the fillslope leading to failure.

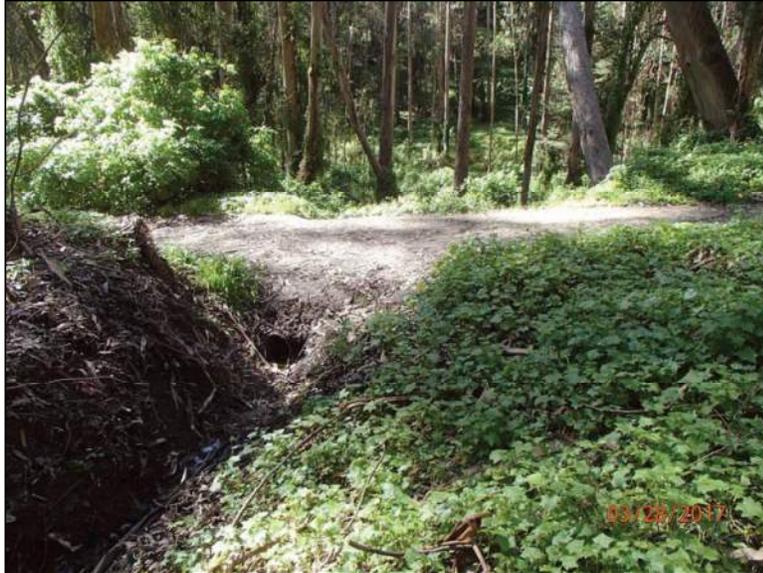
Photo 27 (Site #36): View of a culvert inlet on a small Class III stream at Site #36. This site is downstream of the pond Site #37 in the base of the quarry.

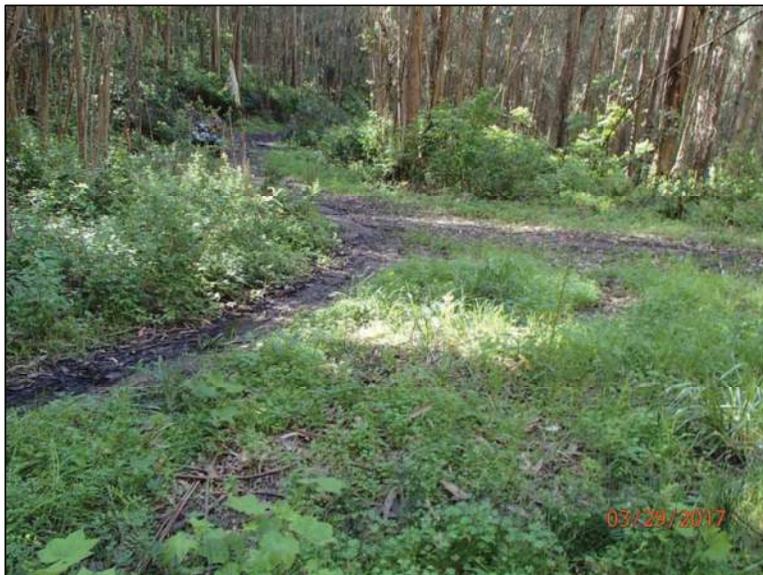
Photo 28 (Site #38): View of the right road approaches to a fill on crossing on a Class III stream on the South Ridge Trail.

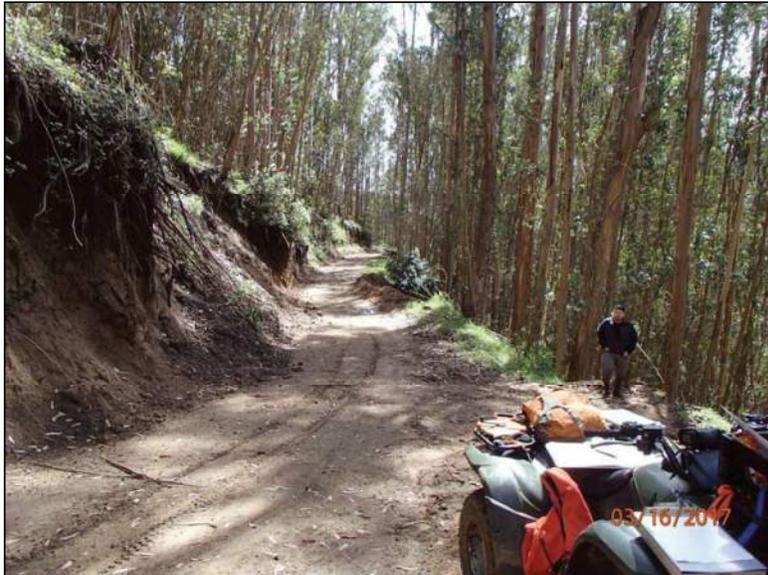
Photo 29 (Site #11): View of the hydrologically connected left road approach to landslide Site #11. Long reaches of concentrated road runoff have eroded a gully down the outboard fillslope and induced a failure.

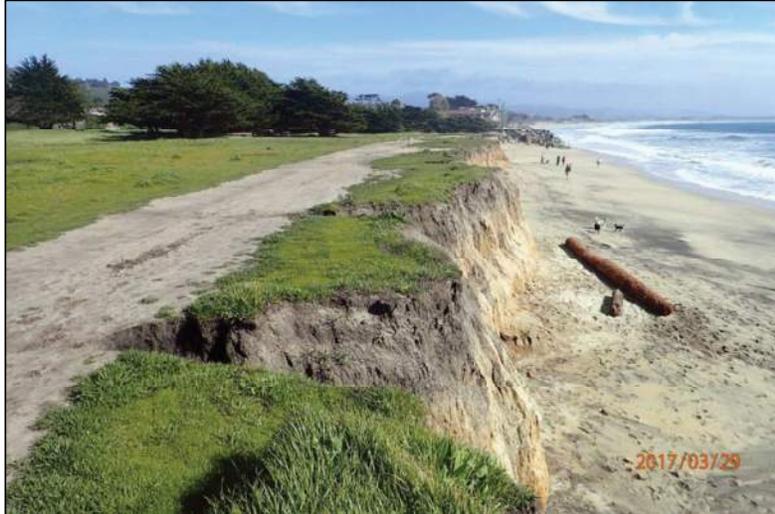
Photo 30 (Coastal Bluff Trail): View of bluff retreat looking south along unpaved coastal trail. The gullies located along the wave cut bluffs are exacerbated by concentrated runoff from the trail and upslope marine terrace meadows.

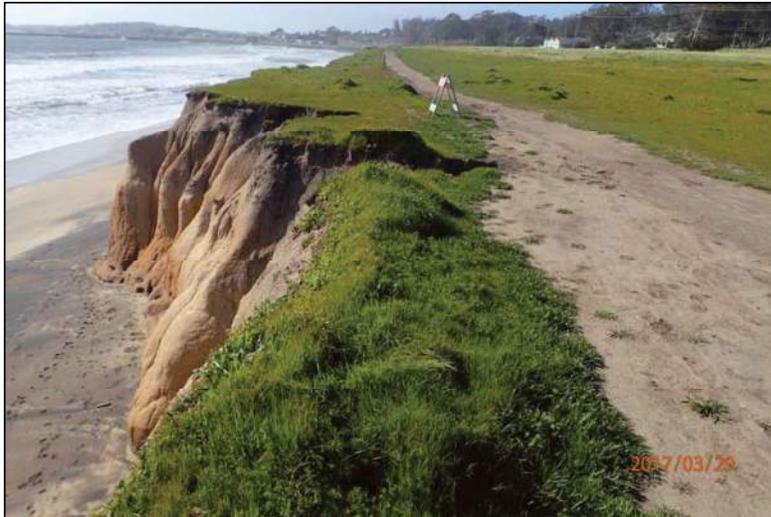
Photo 31 (Coastal Bluff Trail): View of bluff retreat looking northward along unpaved coastal trail. This photo is looking up the hydrologically connected right road reach to the gullies displayed in the previous photo.

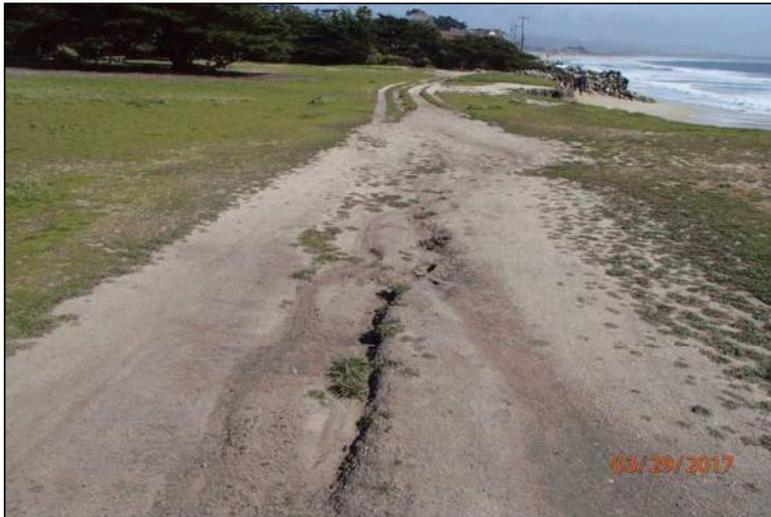
Photo 32 (Coastal Bluff Trail): View of road surface erosion along the coastal trail due to concentrating runoff. Note the exposed beach protection rock armor at the edge of the park boundary in the distance.

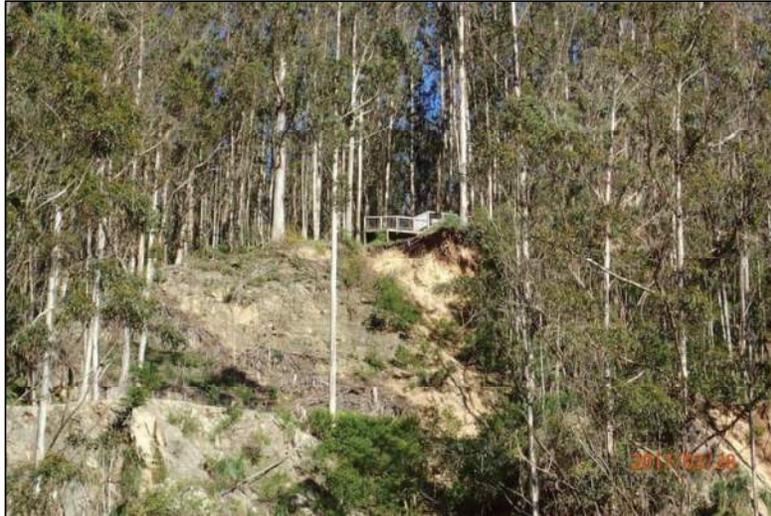
Photo 33 (Lookout Vista): View of the lookout deck and failing hillslope below the outermost footing. This photo was taken looking upslope from the base of the quarry floor.

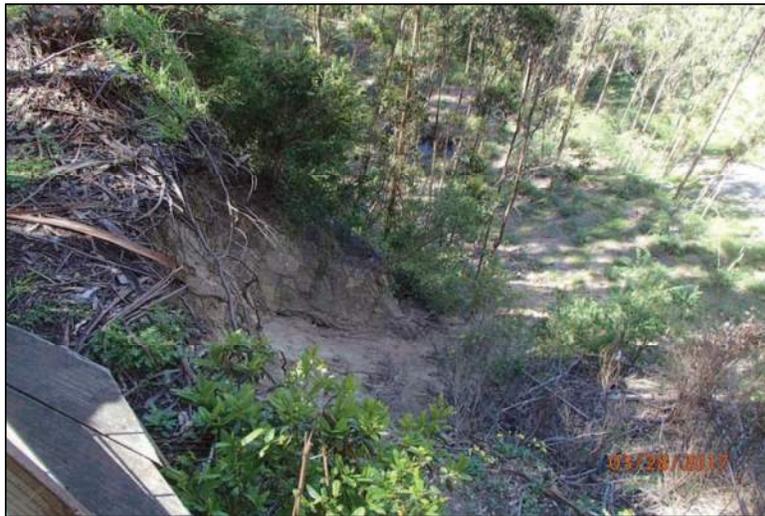
Photo 34 (Lookout Vista): View of the failing hillslope below the wooden lookout vista platform. The quarry cut slope is oversteep and is actively failing in multiple locations along the upper edge of the quarry area.

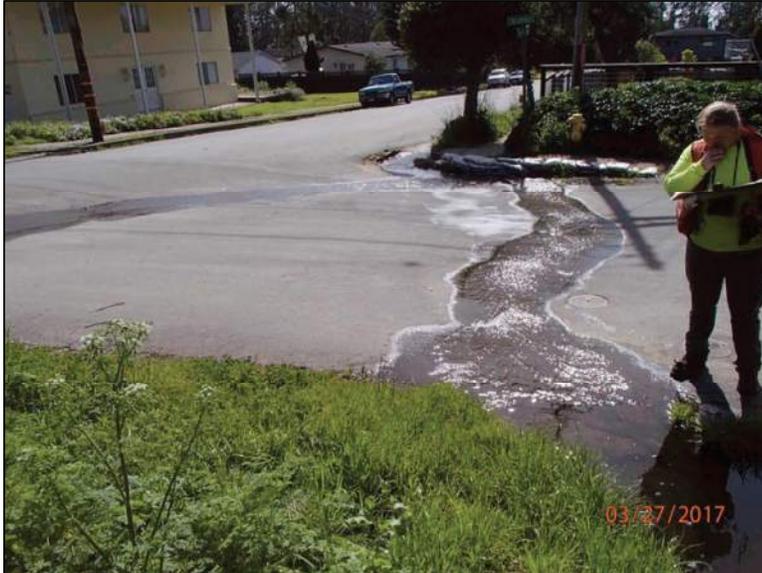
Area of Concern 2 is located at the intersection of Santa Maria Ave. and Columbus St. (Photo 35, Appendix D). This location receives a 0.43 mi² drainage area consisting of the entire Santa Maria drainage along with the majority of the Property's watershed. There is no obvious effort to manage this runoff in any form of designed drainage structure ever. During field investigations, stream flow was observed traveling across and down the paved road, choosing its' own flowpath. Anecdotal accounts from residents report flow exiting the Property has resulted in flooding a large portion of the neighborhood during peak storm events. It should be noted that addressing the problem in this AOC would require collaboration with other entities, which may include City, County, and/or private landowner(s) since area is located outside Park's property boundaries.

Photo 35 (Urban Drainage Interface - AOC 2): View of uncontrolled Class II stream flow exiting the Park at Santa Maria Avenue (AOC2, Map 2). Combined flow from the stream and road surface runoff travel down Santa Maria Ave. The majority of the Park’s drainage area evacuates the Property into the residential area downstream at this location.

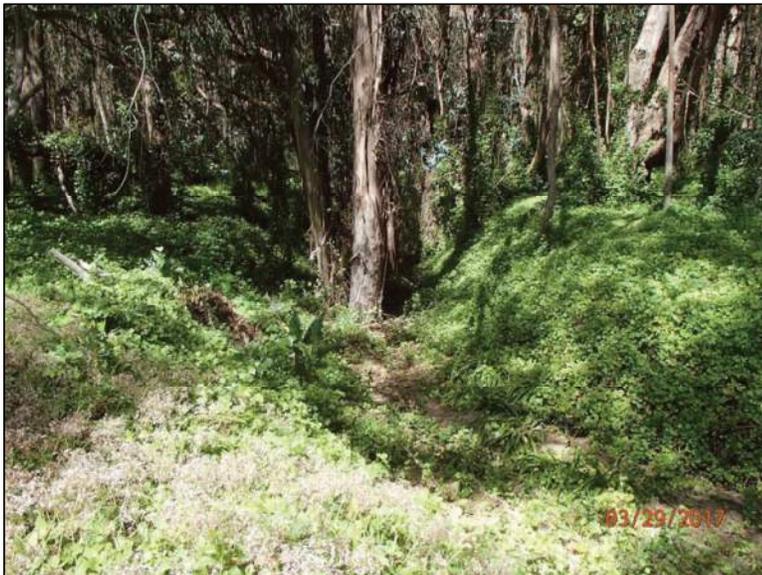
Photo 36 (Urban Drainage Interface - AOC 3): View of a seasonal Class II stream channel downstream from Site #39, ~30 ft upstream from an uncontrolled urban drainage interface (AOC 3) at Moro Drive on the south western boundary of the Park (AOC3, Map 2).

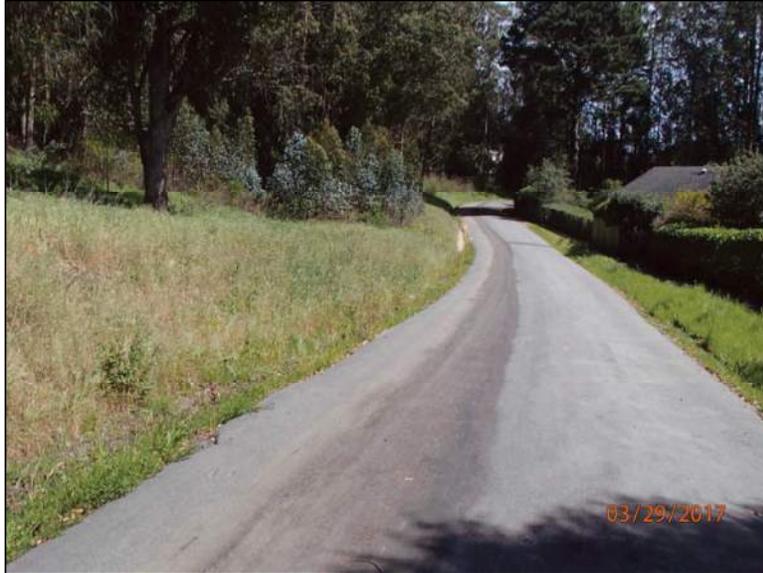
Photo 37 (Urban Drainage Interface – AOC 3): View of the urban drainage interface located on Moro Ave, (AOC 3, Map 2). Flow is conveyed down the inboard ditch for ~325' to a ditch relief culvert at the intersection of Santiago Ave. and Moro Ave. The crowned road surface keeps the majority of the stream flow on the inboard edge of the road.

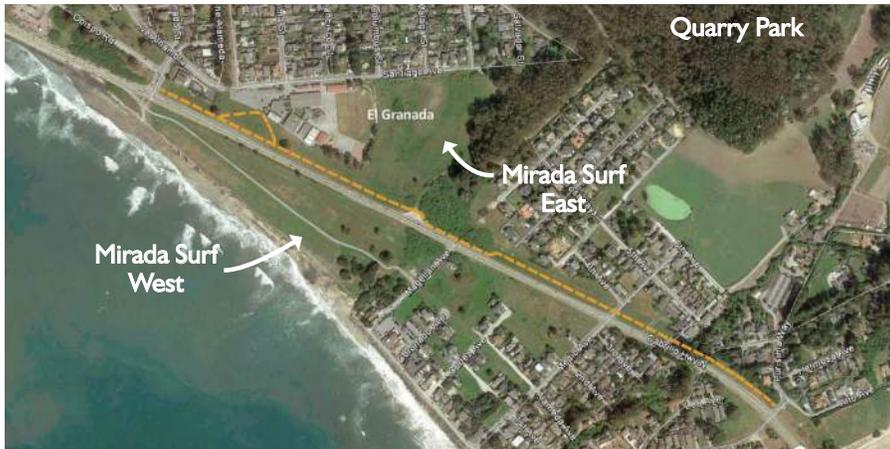
↑ — Approximate Trail Alignment

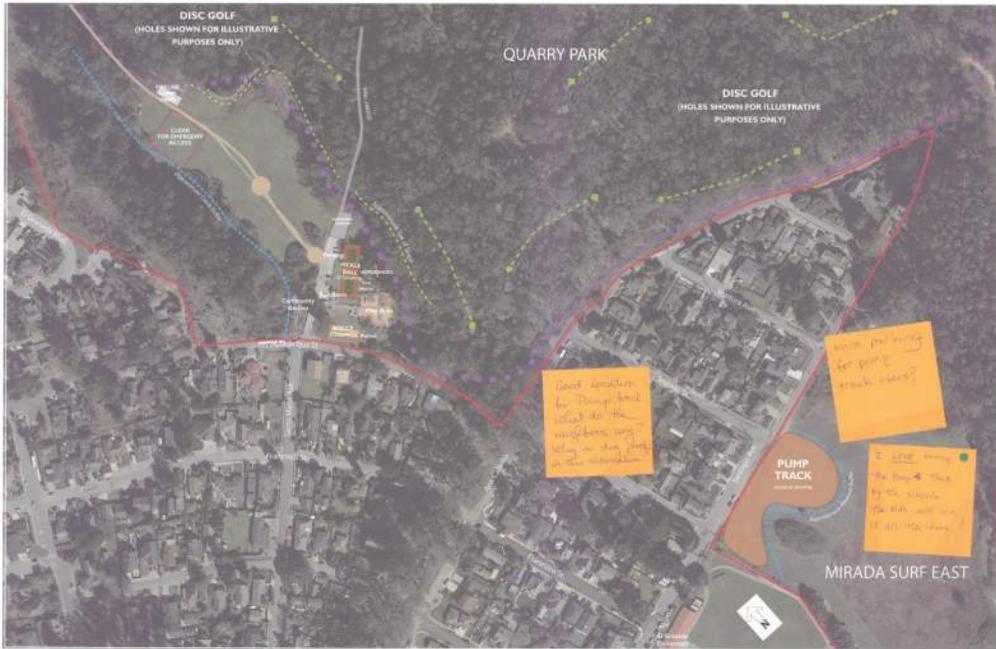
ALTERNATIVE 2

USE	LOCATION		
	Meadow (Garden Side)	Meadow (Playground Side)	Mirada Surf (East)
Fenced Off-Leash Dog Park	None - Possible off-leash trails/days/times		
Pump Track			X
Bocce		X	
Horseshoes		X	
Pickleball		X	
Disc Golf	Approximate extents as shown on map

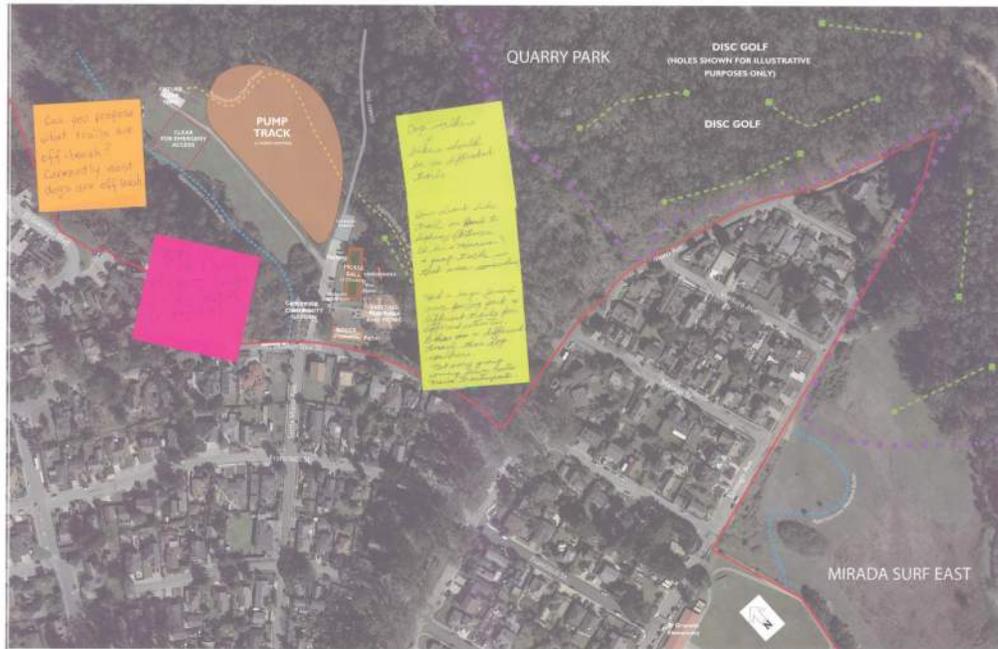
ALTERNATIVE 3

- Existing Multiple-use Trail (Bicycling/roller skating)
- Proposed Multiple-use Trail (Bicycling/roller skating)
- Existing Hiking Only Trail
- Proposed Hiking Only Trail
- Potential Future Hiking Only Trail (currently unmaintained)
- Proposed Downhill Mountain Bike Trail (One Way)
- Proposed for Decommission
- Alternative 3 Disc Golf (Approximate Extents)
