Biological Resources Assessment

SAN MATEO COUNTY QUARRY PARK MASTER PLAN PROJECT EL GRANADA, SAN MATEO COUNTY, CALIFORNIA

APPENDIX B | WATERSHED ASSESSMENT AND EROSION PREVENTION PLAN

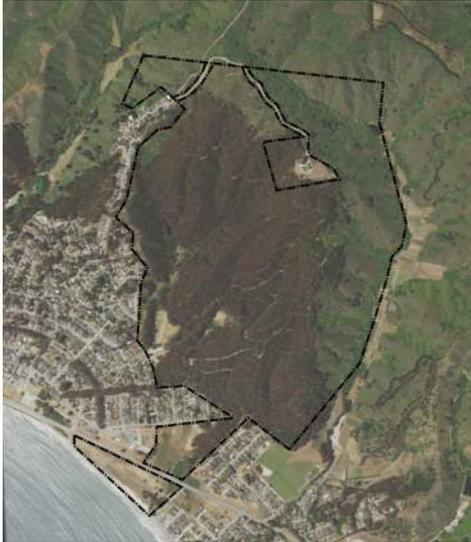
DRAFT TRAILS NETWORK

- » Importance for emergency vehicle access, fire management, maintenance
- » Impacts on sediment/drainage
- » Impacts on natural resources
- » Recreation value
- » Creation of loops and connections

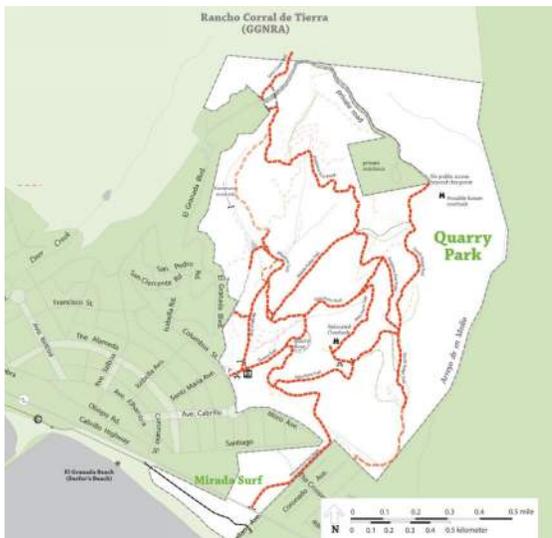
— MULTIPLE USE TRAILS

- » Improve multi-use trail networks
- » Decommission non-essential problematic trails
- » Provide networks for maintenance, fire management and safety
- » Provide educational, information and interpretive trail signage system
- » Relocate look out
- » Continue use of Quarry Floor for events

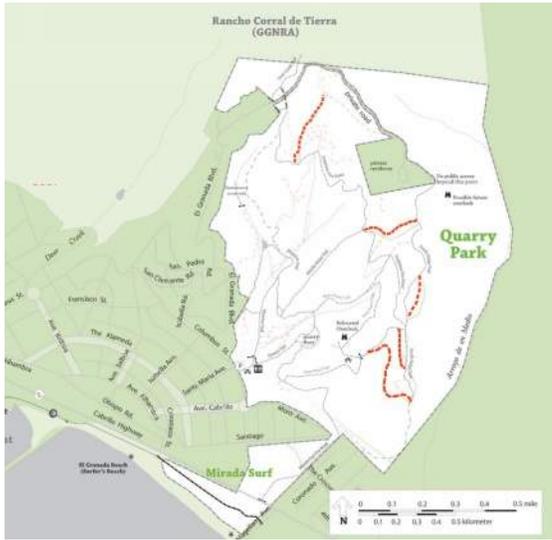
HIKING ONLY TRAILS

- » Bicycles not permitted
- » Signage

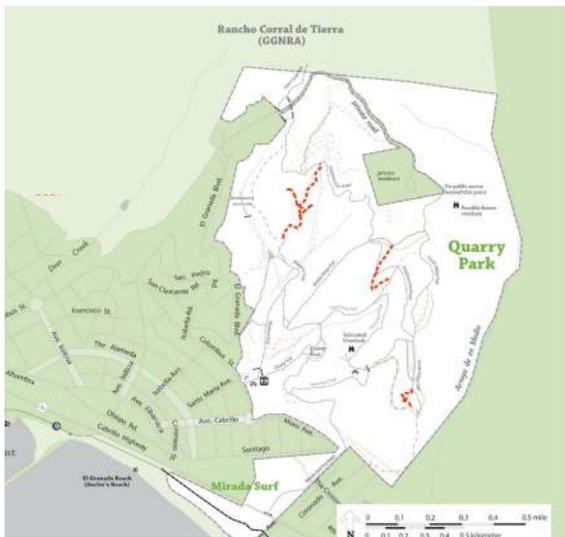
MOUNTAIN BIKE ONLY TRAILS

- » Potential downhill mountain bike trails identified
- » Revision to County ordinance to be recommended
- » Signage to be recommended (identification, safety)

- » Potential downhill mountain bike trails identified
- » Revision to County ordinance to be recommended
- » Signage to be recommended (identification, safety)

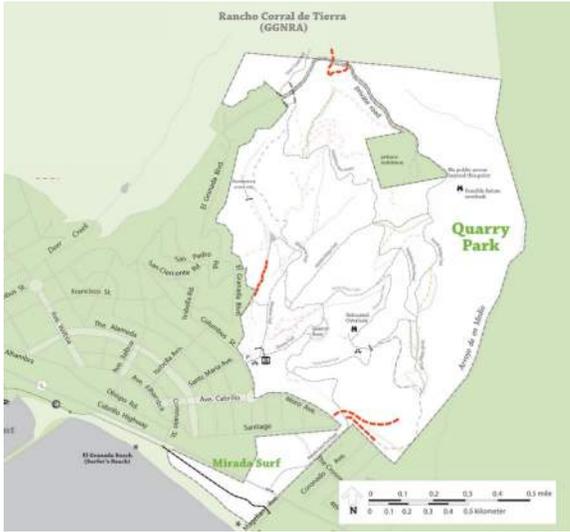
CONNECTIONS

- » Recommended connections to GGNRA (needed easements to be explored)
- » Connection between South Ridge Trail and Mirada Surf East to create loop
- » Access from end of El Granada Blvd.
- » Connect Mirada East Road & South Ridge Trail

- » Recommended connections to GGNRA (needed easements to be explored)
- » Connection between South Ridge Trail and Mirada Surf East to create loop

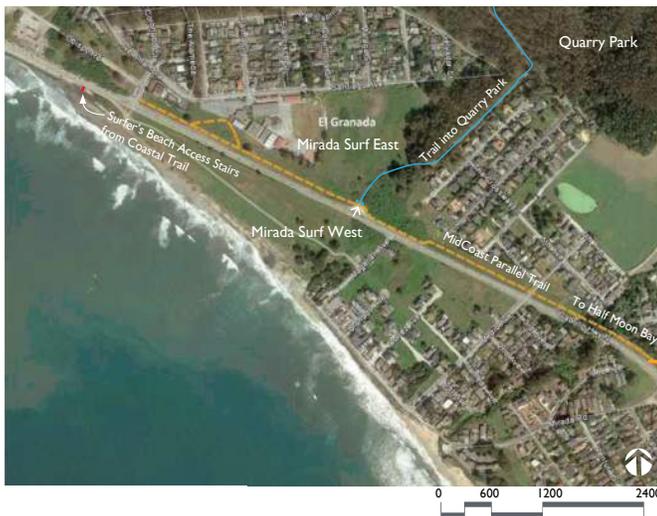
PARALLEL TRAIL

Parallel Trail will be in Caltrans R.O.W., managed by County

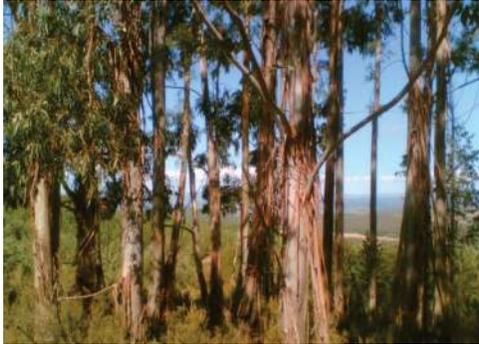
— FIRE MANAGEMENT

- » Thin eucalyptus to reduce fire risk, create shaded breaks along trails
- » Maintain existing fire buffers on north and south sides of the park

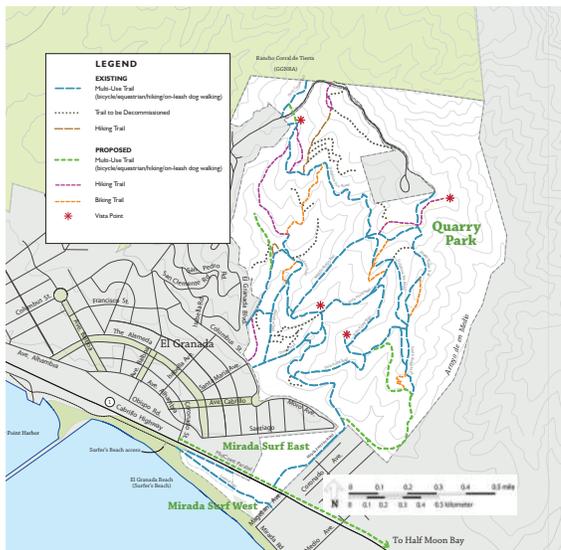
— INTEGRATED TRAIL SYSTEM

- » Provide networks for maintenance, fire management and safety
- » Provide informative trail signage system

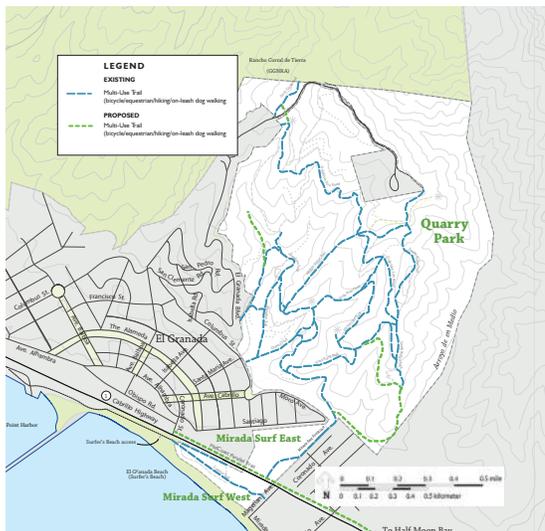
MULTI-USE TRAILS

- » Provide networks for maintenance, fire management and safety
- » Designate on leash trails
 - New dog management policies were approved by the San Mateo County Parks and Recreation Commission
 - New County ordinance is being developed
 - Quarry Park grandfathers in limited dog access

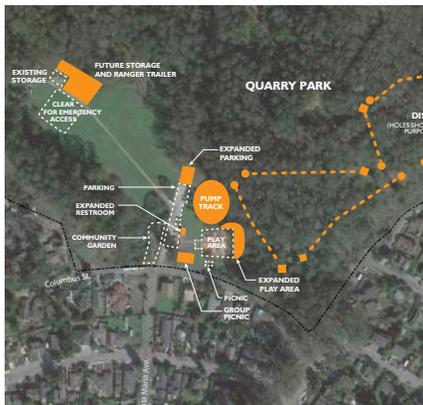
EXPANDED PLAY AND PICNIC AREAS

- » Reservable picnic area
- » More play structures
- » More space

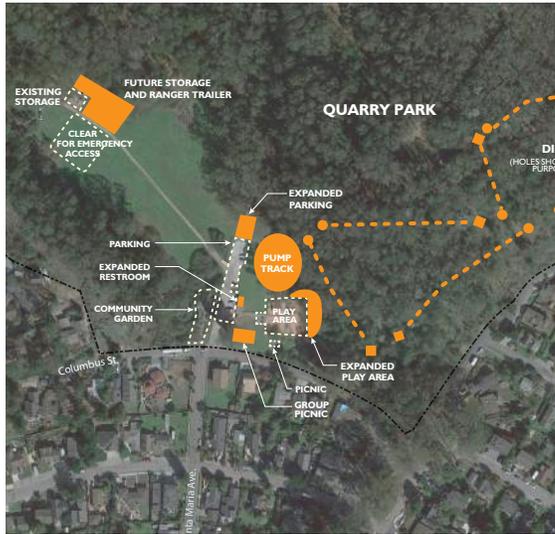
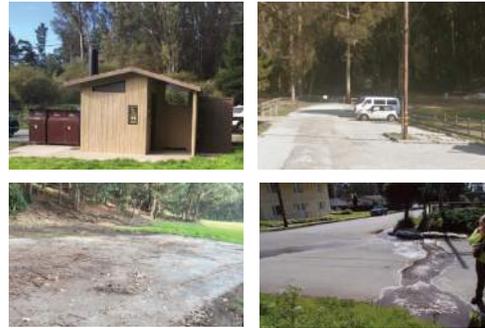
INFRASTRUCTURE

Existing storage pad: expand for additional park storage and administration
Address drainage to the street

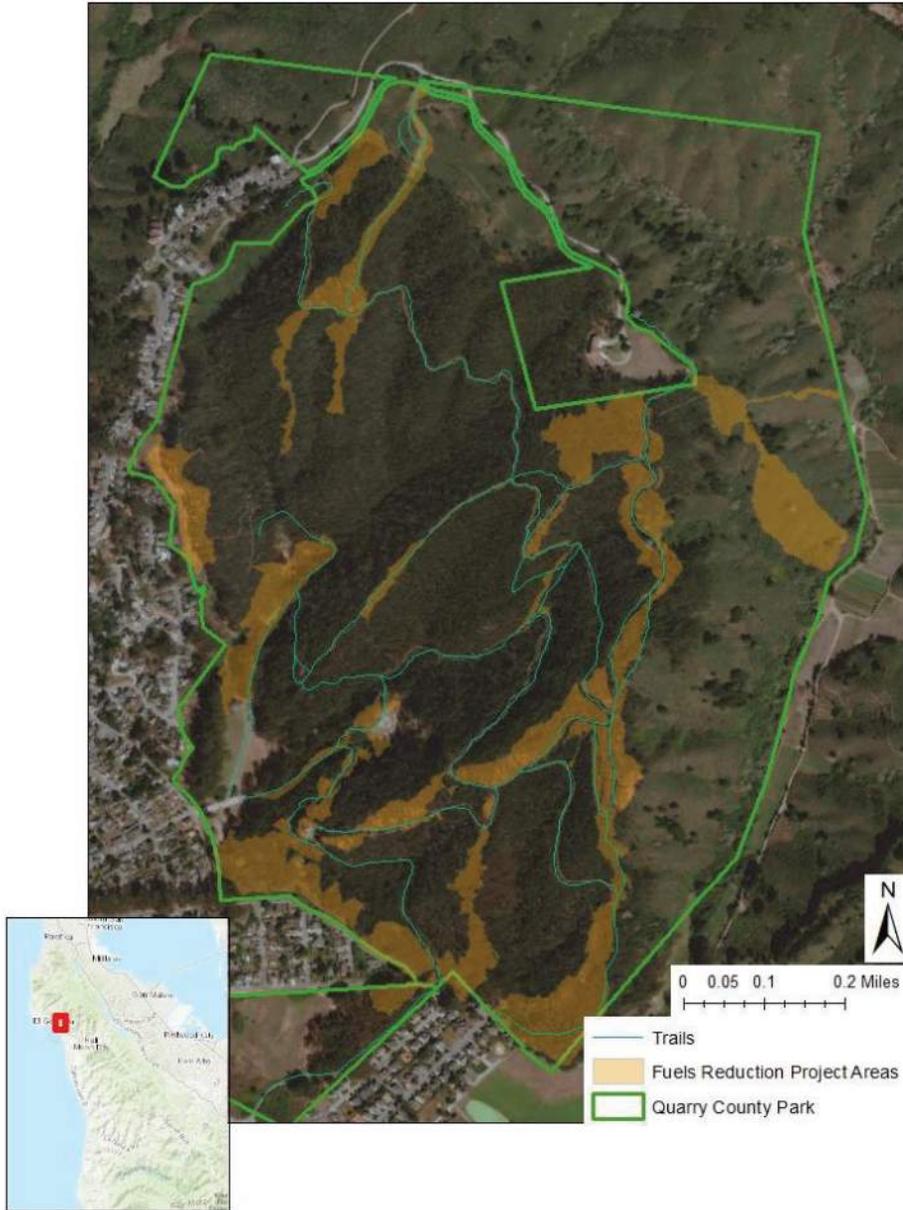
Quarry County Park:
Maintain Governor's Fuel Reduction Project

County Parks Natural Resource Management staff to manage project implementation with County Contractor(s), provide environmental avoidance & minimization measures, and monitor project area.

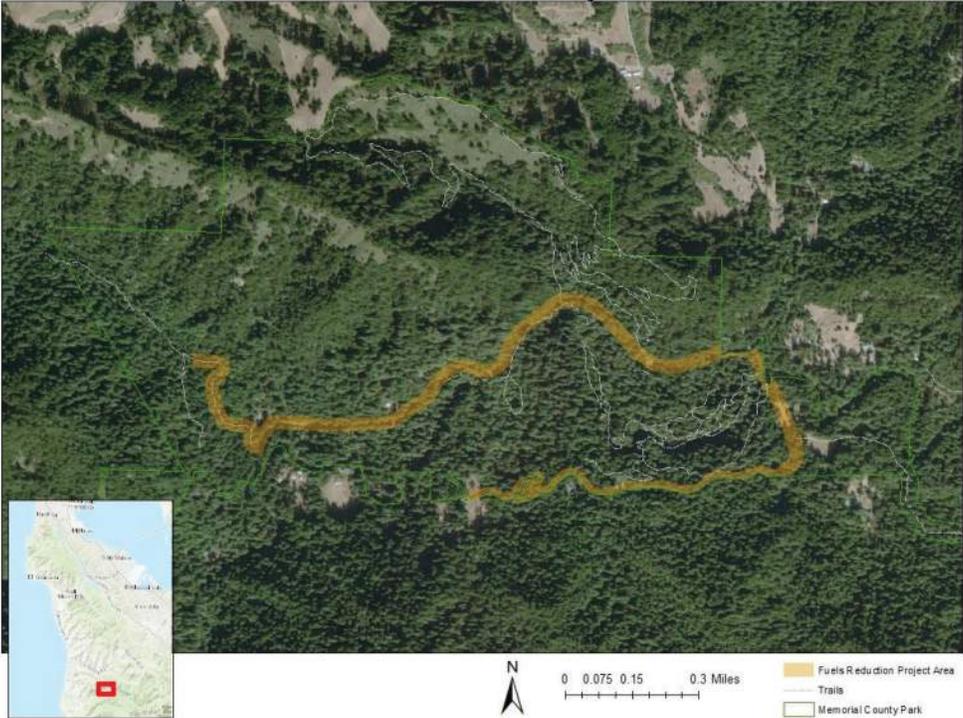
Memorial County Park: Create and Maintain Shaded Fuel Breaks Along Pescadero Creek Road and Wurr Road

Treatment Types: Install shaded fuel break by removing ladder fuels and standing dead hazard trees which pose a strike potential to roadways.

Treatment Methods: Hand felling and processing debris with chipper, use of burn piles where feasible. Mechanical treatment using masticators where access and terrain allow.

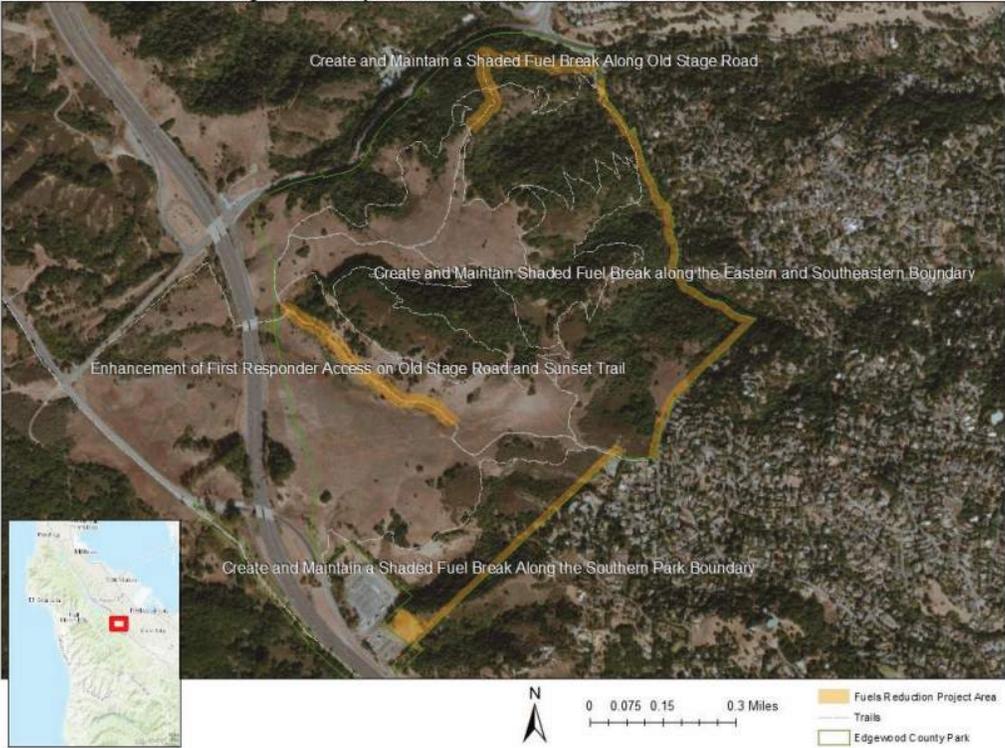
Edgewood County Park and Natural Preserve: Fuels Reduction Areas

Install shaded fuel break by removing ladder fuels and standing dead hazard trees. Understory thinning should include California Bay to reduce Sudden Oak Death vectors

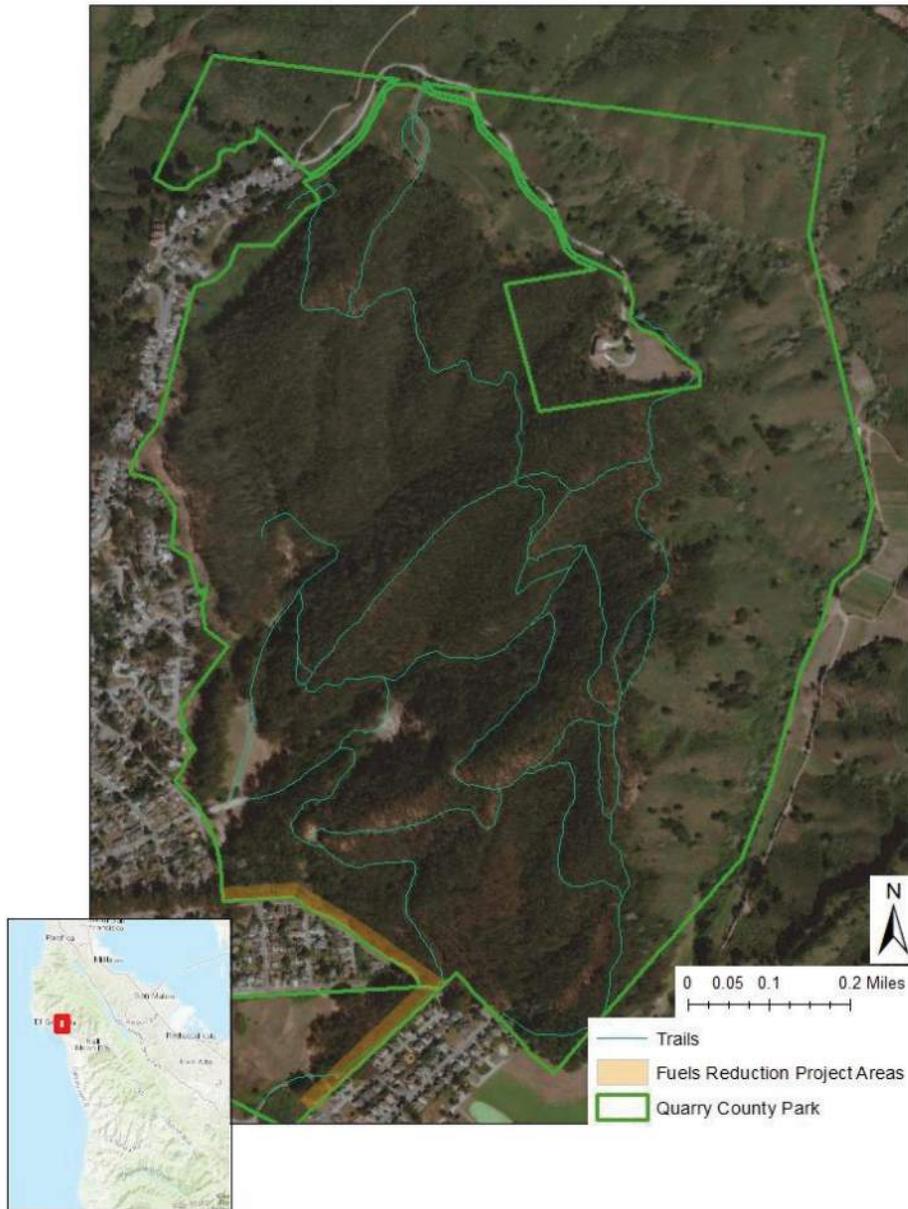
Quarry County Park:
Create and Maintain a Shaded Fuel Break Along Western Park Boundary

Treatment Types: Understory thinning of Tasmanian Blue gum, acacia, Monterey Pine and other non-native invasive vegetation and large diameter standing dead tree hazards. Felling and chipping of tree debris on site.

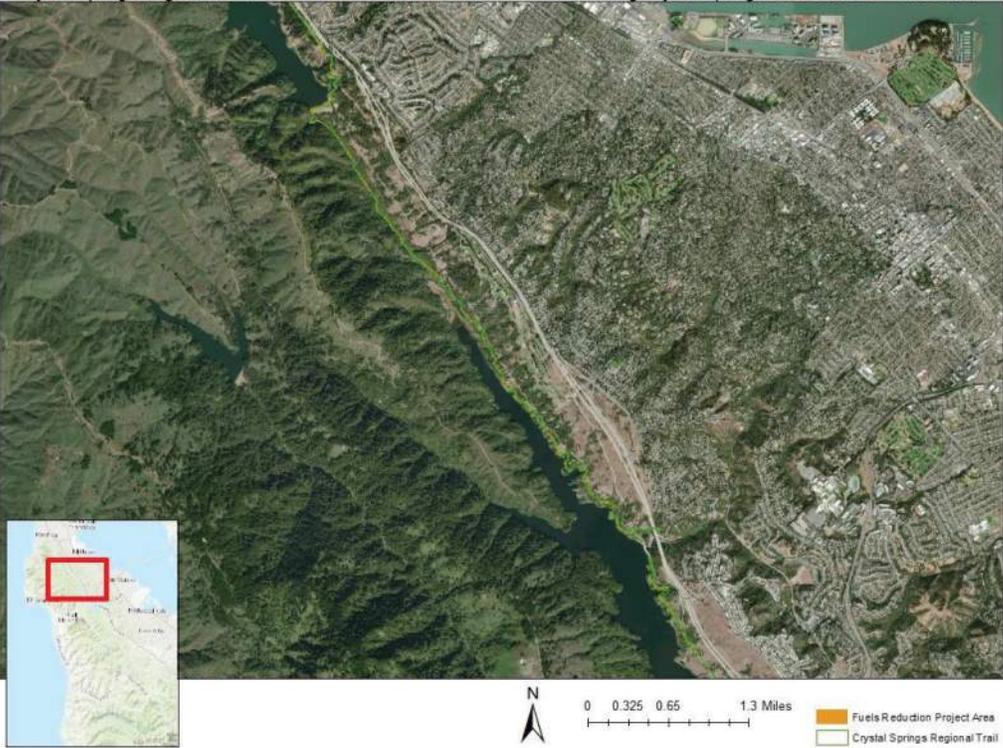
Crystal Springs Regional Trail: Create and Maintain a Shaded Fuel Break Along Crystal Springs Road Corridor - San Bruno

Project Description and Parameters: Following CAL FIRE recommendations, improve the security of a critical evacuation route for portions of San Bruno.

Treatment Methods: Use of California Department of Conservation and Rehabilitation Hand crews, Park staff, CAL FIRE and County contractors. Hand cut vegetation and process with chippers. Use of mechanical methods where slope and environmental conditions allow.
