CSA 7 - Water System Feasibility Study and Seismic Retrofit Project Water System Improvement Recommendation Report

Prepared For:
COUNTY OF SAN MATEO
PUBLIC WORKS DEPARTMENT
Project # 12-075, October 2015

Water System Improvement Recommendation Report

Date: October 12th, 2015
Prepared by: Jigar Shah, PE
Anthony Baltazar, EIT
Tim Lewis, EIT
Checked by: Mike Fisher, PE

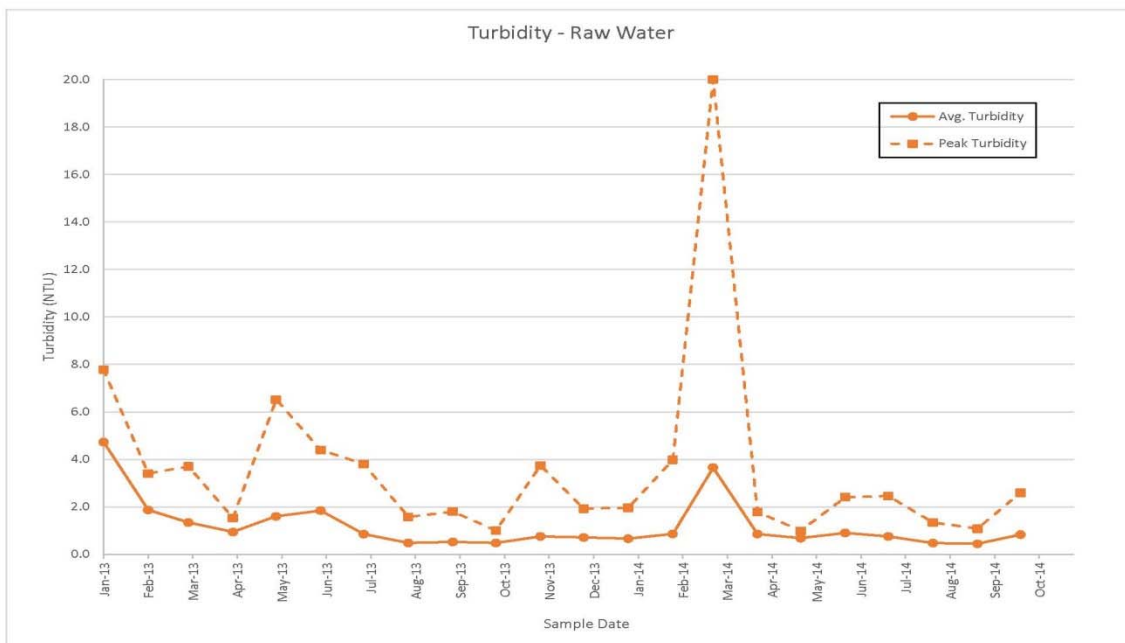
Figure 4: Raw Water Turbidity Data

As displayed in Figure 4 the County has observed the turbidity of the raw water increase during heavy rainfall events when the water level is high in the Alpine Creek. Thus, removal of high turbidity is essential in improving the water quality for the customers of CSA 7.

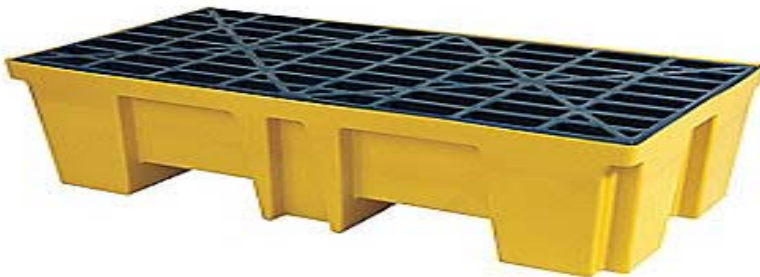
Figure 10: Chemical Containment

The recommended chemical containment for the chemical drums will be similar to Brady SPC Absorbents Spill containment pallet made of HDPE material. The containment size is 17”H x 26”W x 52”L providing up to 68-gallon capacity, which is double the volume of the chemical containers. Figure 10 shows the spill containment pallet for chemical containment. A seismic stainless steel strap similar to a household water heater strap should be used to anchor the chemical drums to the WTP wall.

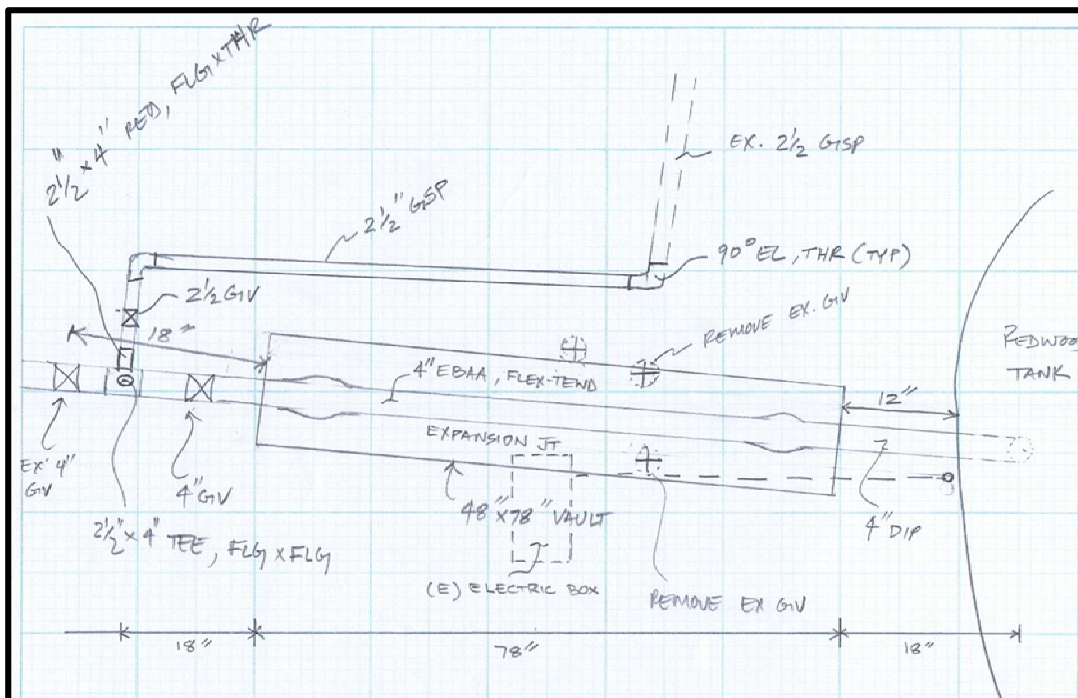
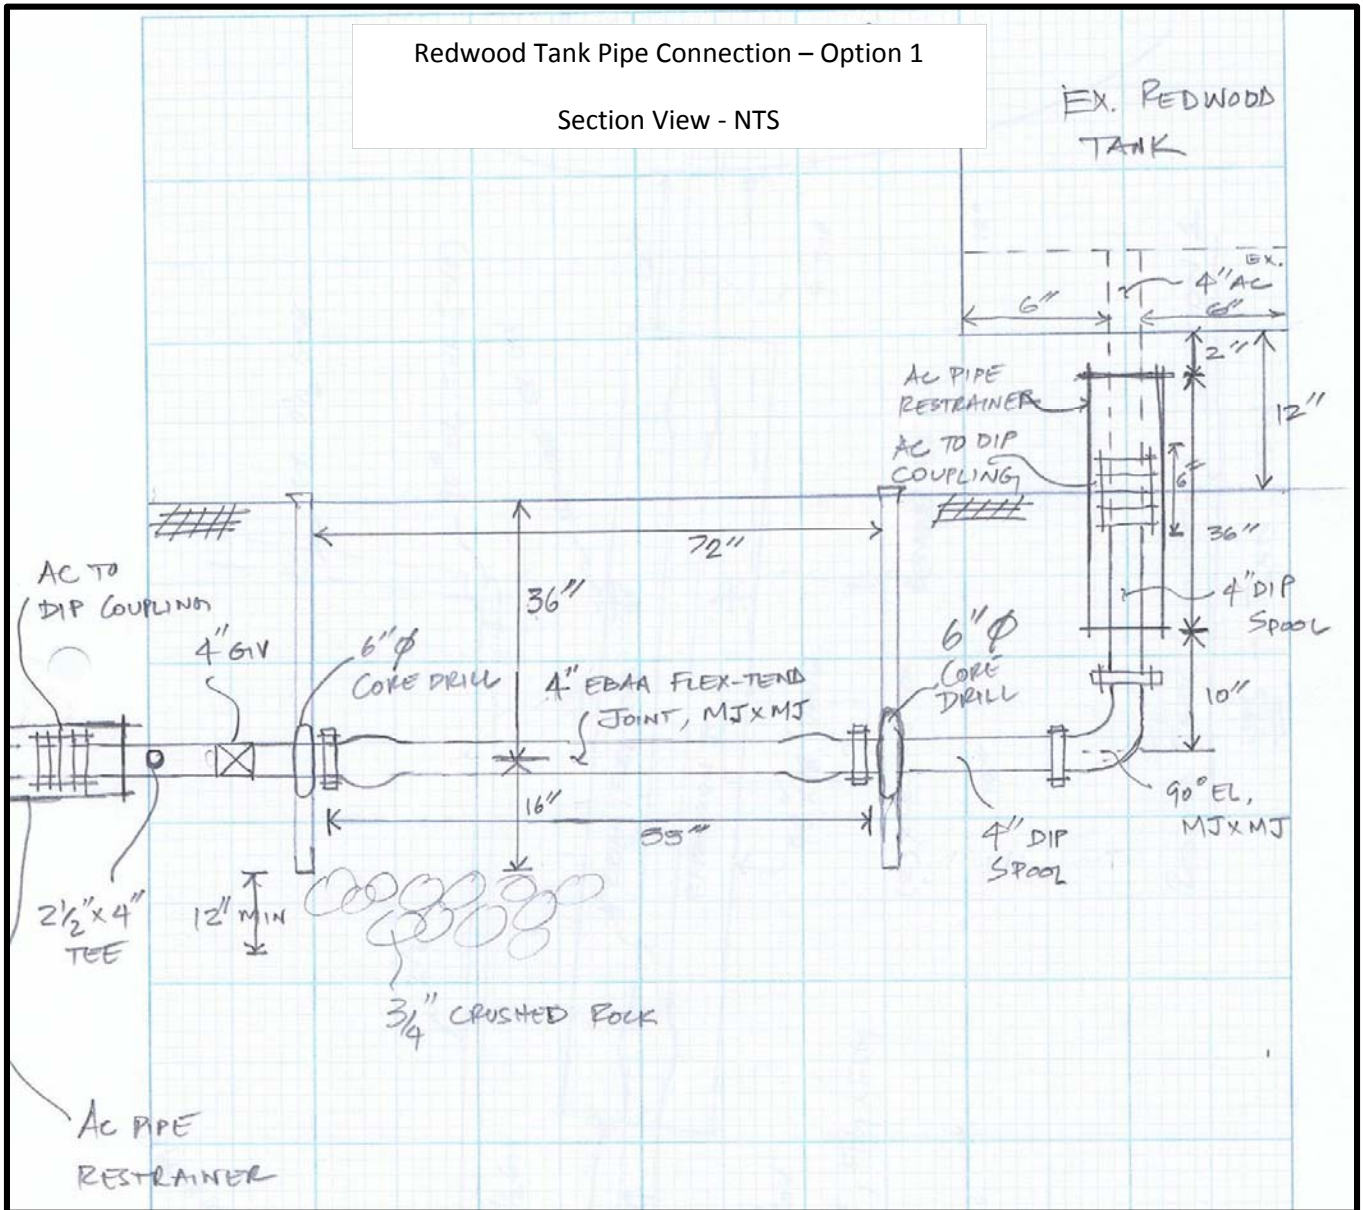
Figure 14: Raw Water Tank – Pipe Connection

Option 1 incorporates an EBAA Iron force-balanced Flex Tend coupling that has an ability to deflect up to 20 degrees in all directions and can move laterally or horizontally for up to 8-inches. Sufficient room for the force-balanced Flex Tend coupling movement shall be provided. Generally, it is placed above ground or in a concrete vault. As shown in **Figure 14**, the EBAA Iron force-balanced Flex Tend coupling is located in a 48" x 72" concrete vault. Other existing pipelines, valves and connection will be relocated and replaced. With this option, the existing electrical box and conduits for the raw water tank level controls will also be relocated.

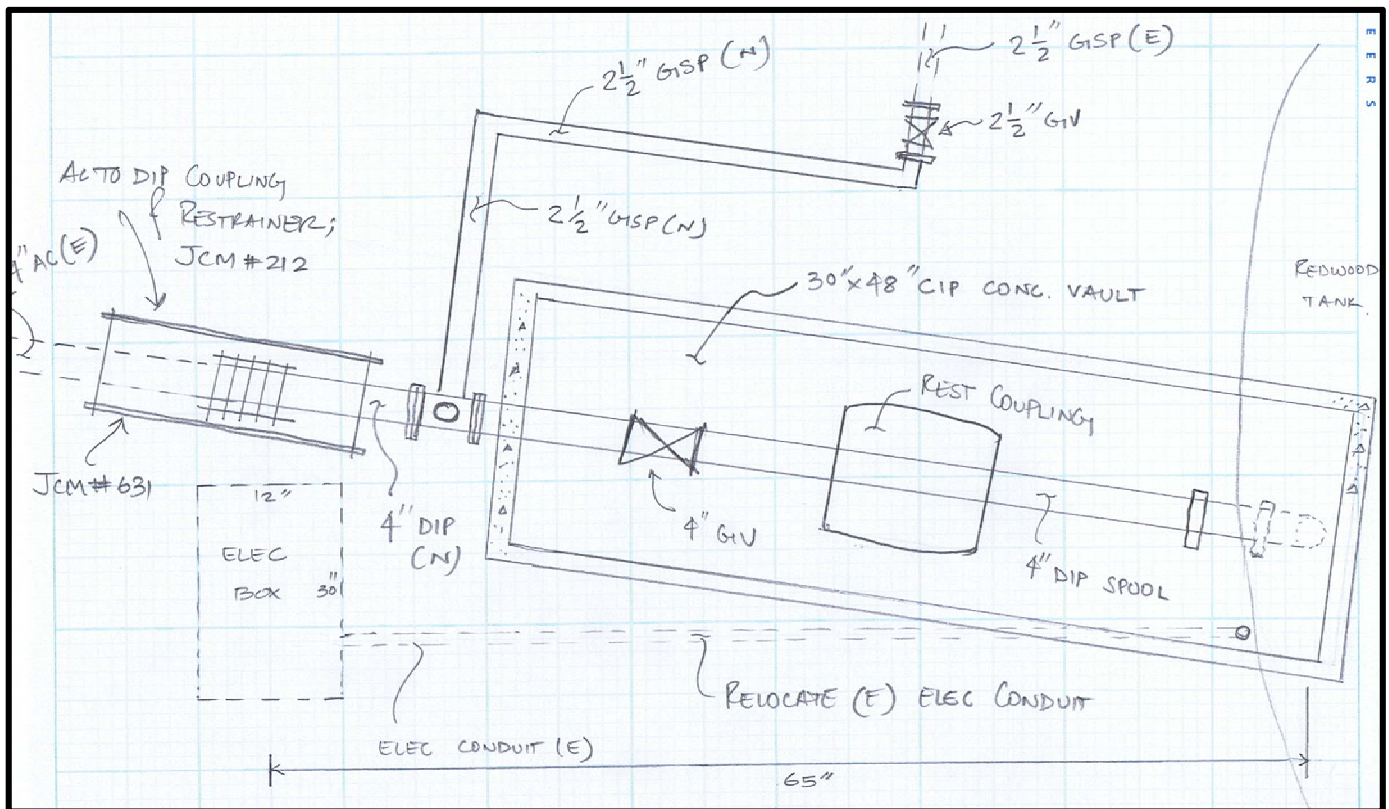
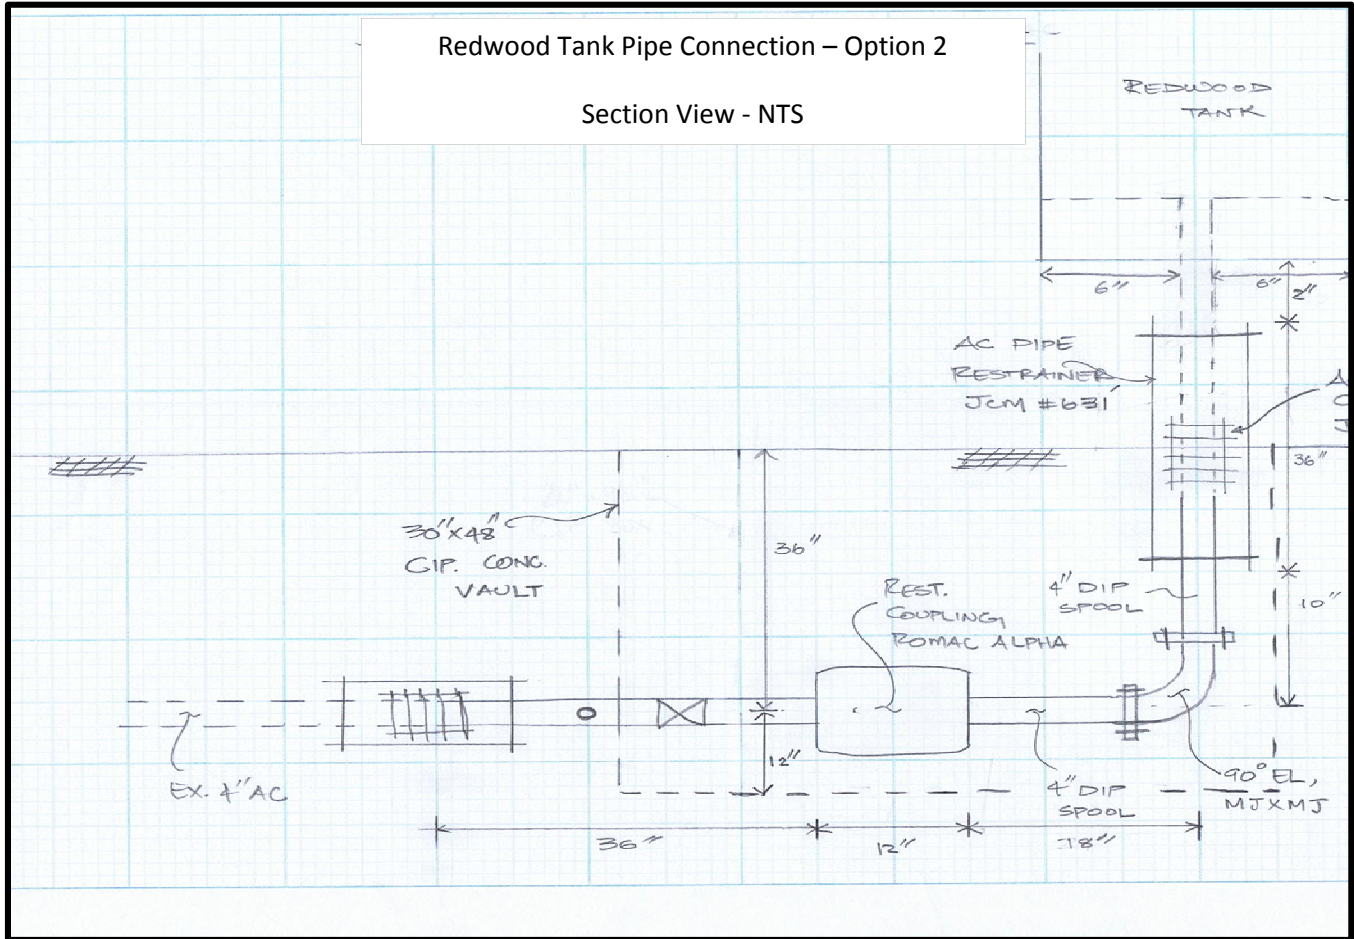
Redwood Tank Pipe Connection – Option 2
 Plan View - NTS

Option 2 uses a Romac Alpha coupling that has an ability to deflect up to 8 degrees in all direction but the lateral and horizontal movement is limited to only 8 degrees of deflection. Sufficient room for the movement in Alpha coupling shall be provided. Generally, it is placed in a concrete vault as depicted in the figure. The existing pipelines, valves and connection will also be relocated and replaced. The existing electrical box and conduits for the tank level controls may not have to be relocated.

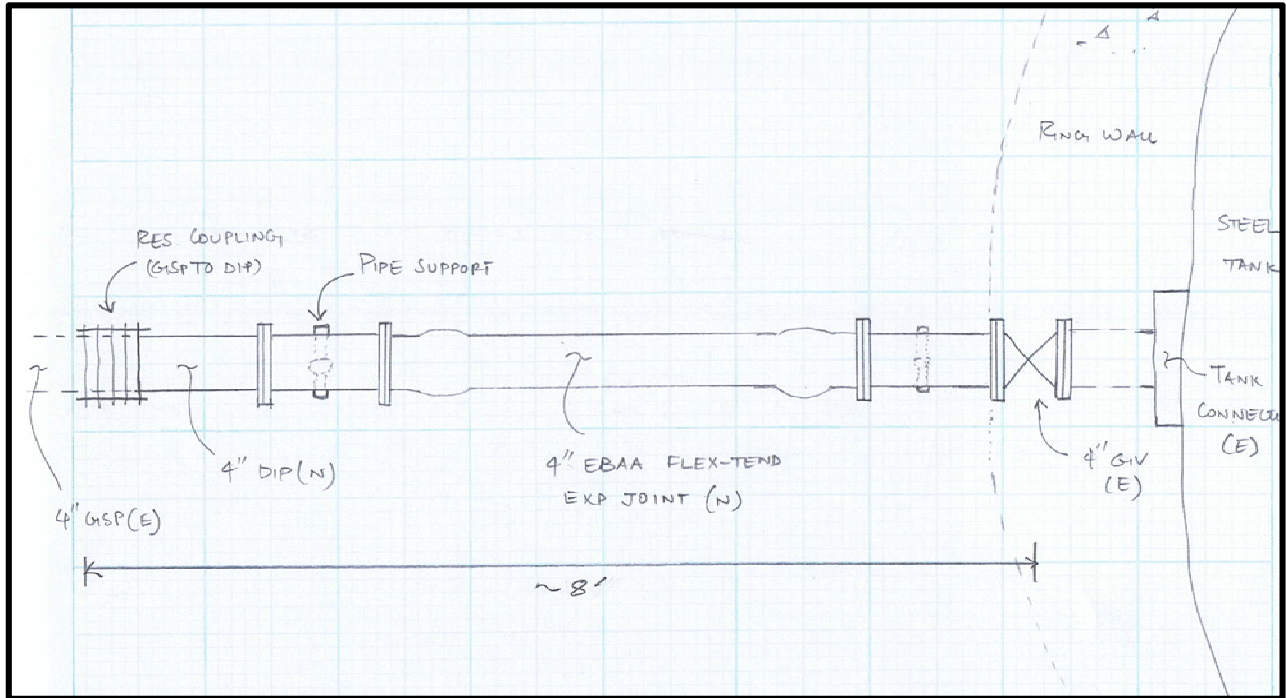
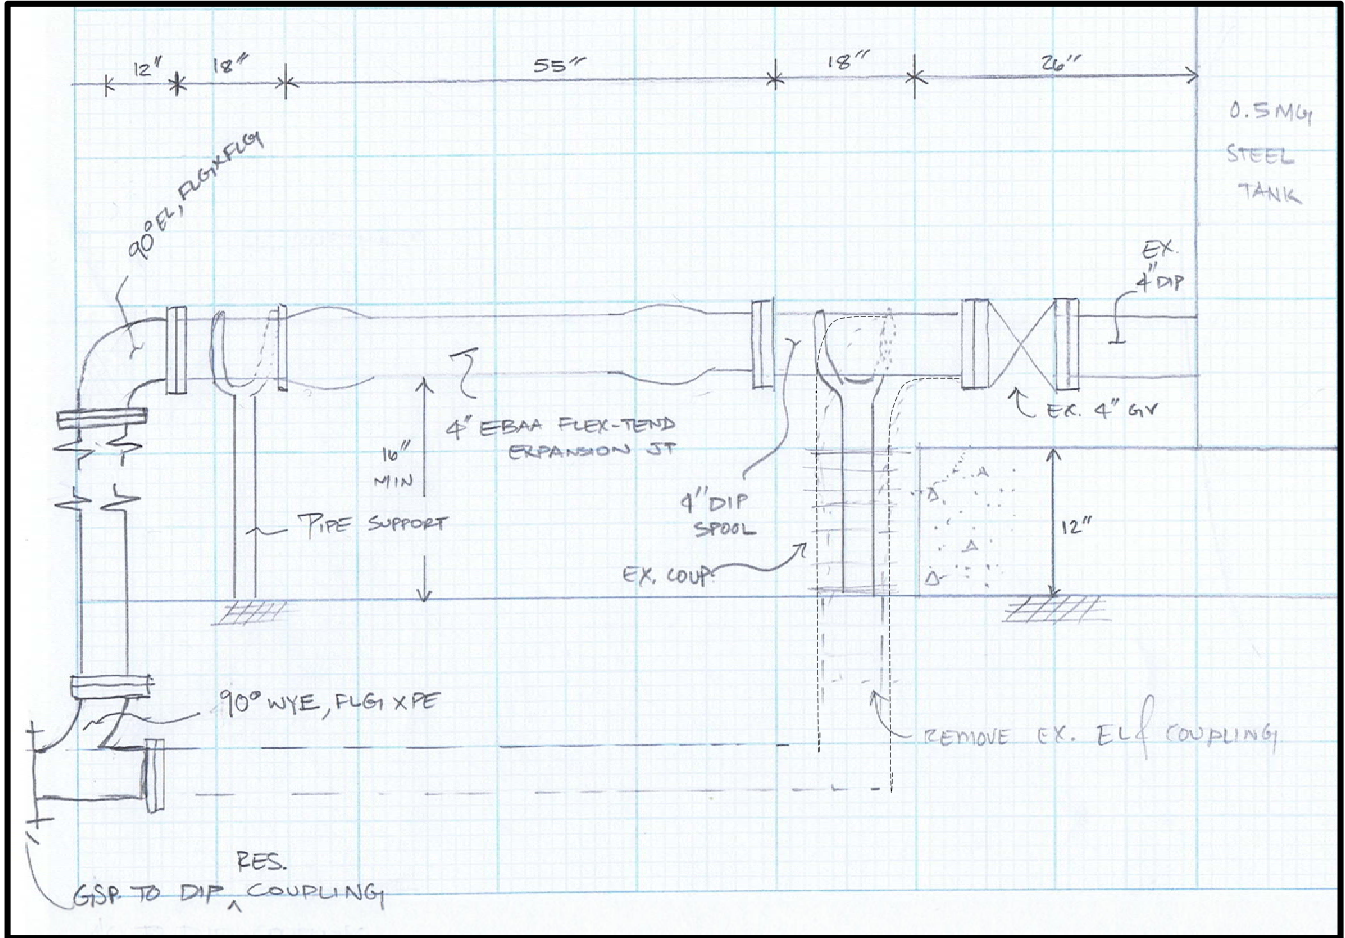
Figure 15: Treated Water Tank – Pipe Connection

WWE evaluated two possible options to secure the existing 4-inch inlet/outlet DIP and GSP using flexible couplings. The two options generally rely on a EBAA Iron force-balanced Flex Tend or a Romac Alpha couplings. Each of these couplings will connect to the 4-inch DIP and an additional coupling is required for transitioning to existing ACP. This connection will be restrained and new 4-inch DIP will be used. **Figure 15** shows both of the inlet/outlet pipe connection options:

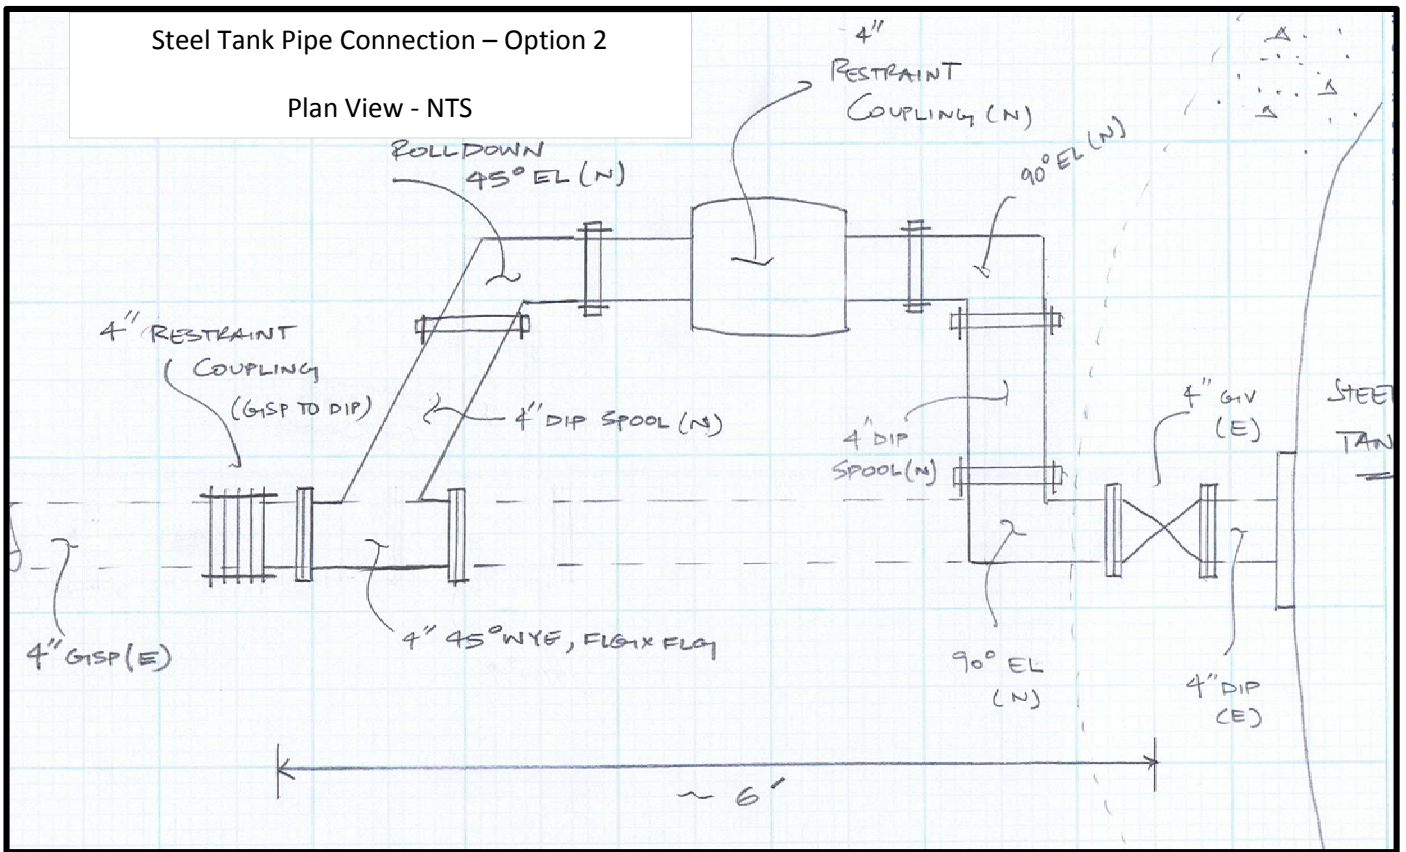
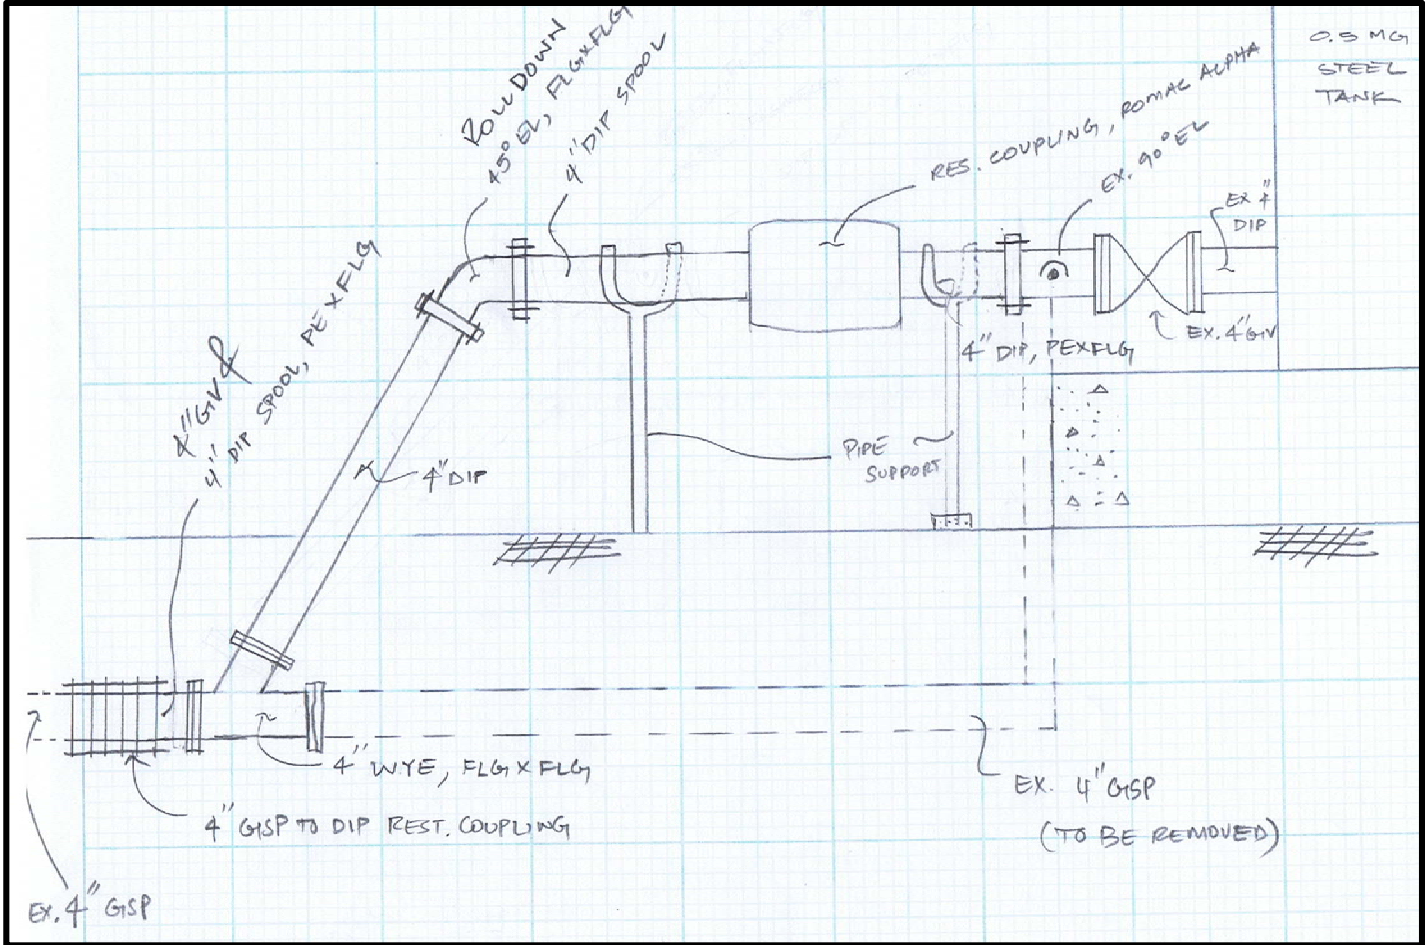
Steel Tank Pipe Connection – Option 2
 Section View - NTS

Option 2 uses a Romac Alpha coupling that has an ability to deflect up to 8 degrees in all directions but lateral and horizontal movement is limited to only 8 degrees deflection. The new piping will have two 90-degree elbows and a 45-degree elbow to provide additional flexibility. The alpha coupling is placed approximately 16-inches above ground to provide sufficient room for deflection. Generally, it is placed in a concrete vault but it can be aboveground.

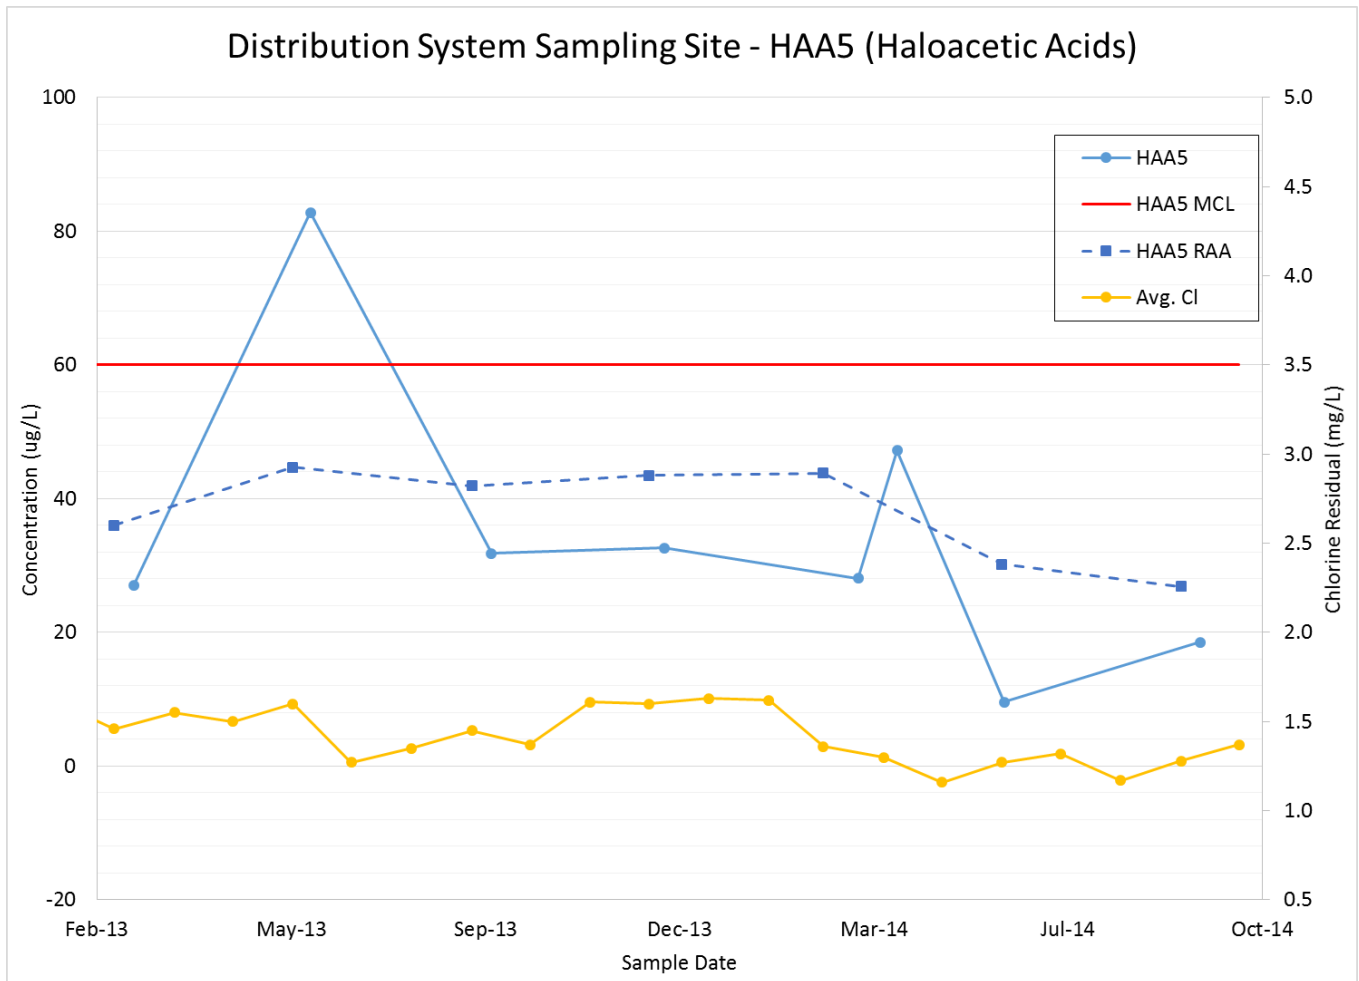
Figure 1. HAA5 Formation in CSA 7 Water System

As can be seen in Figure 1, one sample was above the HAA5 MCL of 60 ug/L. However, the HAA5 RAA has never been in violation of the MCL.

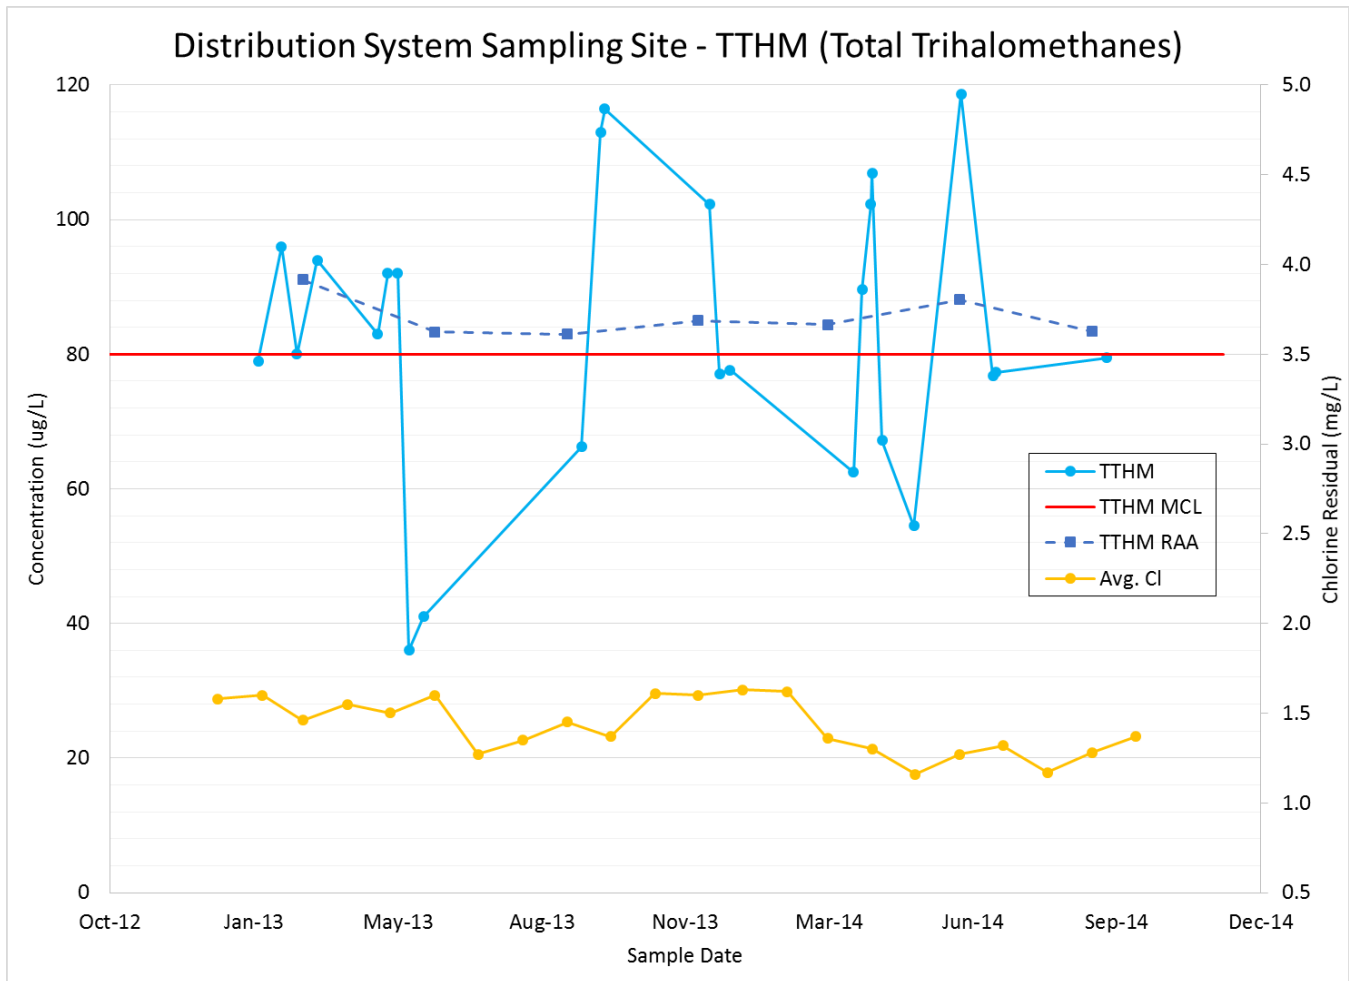
Figure 2. TTHM Formation in CSA 7 Water System

As shown in Figure 2, the TTHM RAA has been consistently hovering just above the regulatory MCL of 80 ug/L. In order to lower the RAA below the MCL, another TTHM strategy must be employed.

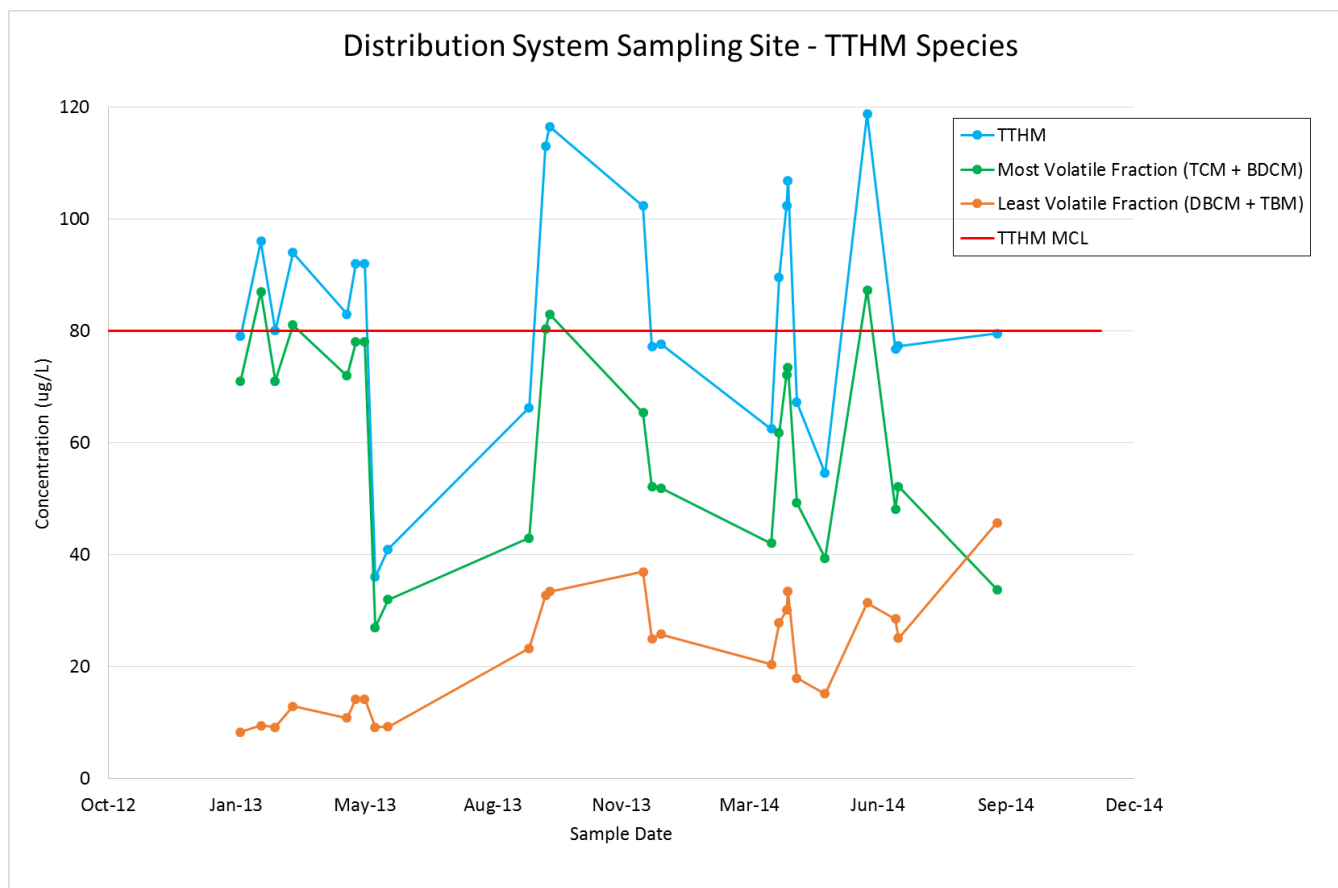
Figure 3. TTHM Species Concentrations in Distribution System

The two species with the highest Henry’s Law coefficients (the easiest to volatilize through air stripping) make up 73% of the TTHM formed, on average. Figure 3 illustrates this point. With the exception of one sample, the sum of the concentrations of the more volatile chloroform and bromodichloromethane, represented by the green line, is much greater than the sum of the concentrations of the less volatile dibromochloromethane and bromoform, represented by the orange line.

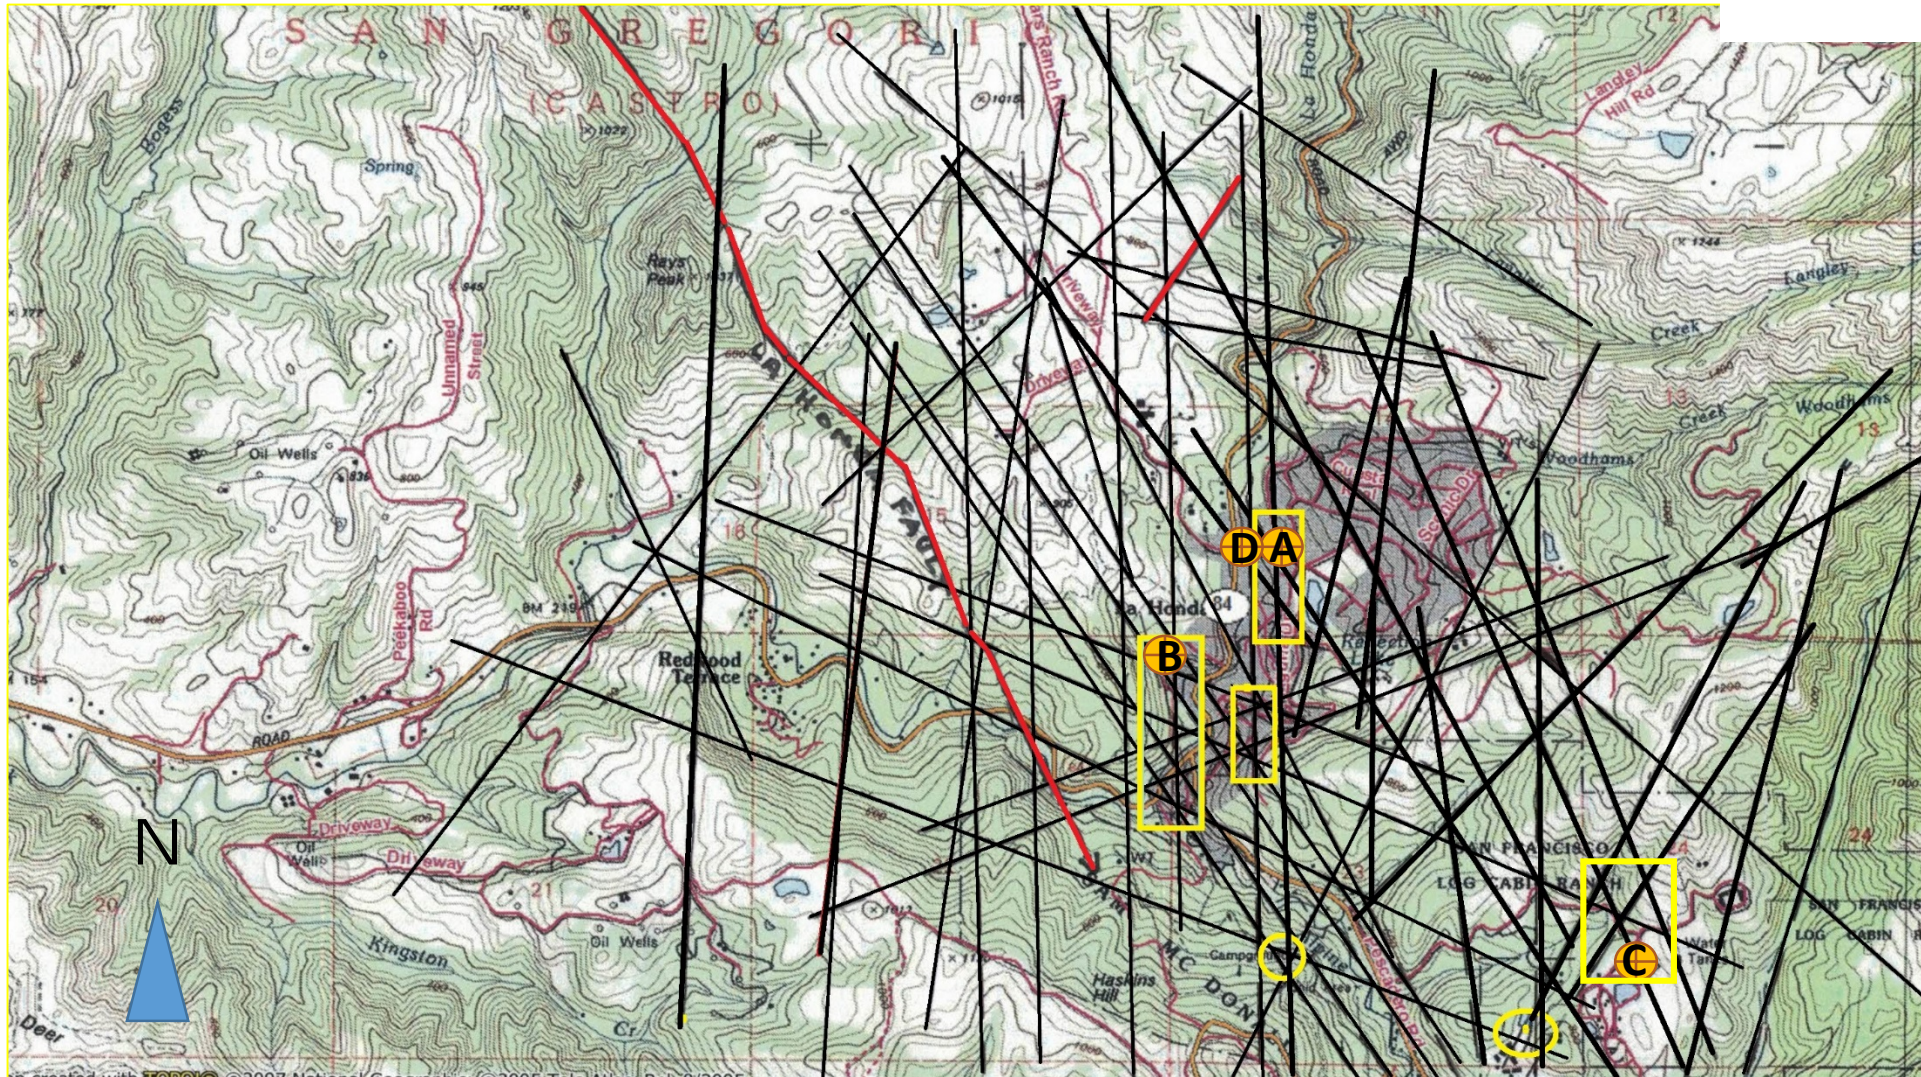
Figure 3
Fracture Trace Analysis &
Recommended Well Site
Areas

The areas marked in yellow immediately west and east of La Honda Creek (Figure 3) likely will provide the best opportunity for the development of production well to meet the needs of CSA No. 7. Of these, the four locations appeared to be the most promising locations for a production well. Photographs of the potential well sites noted on Figure 3 are provided on Figures 4 through 7. The sites in order of preference are:

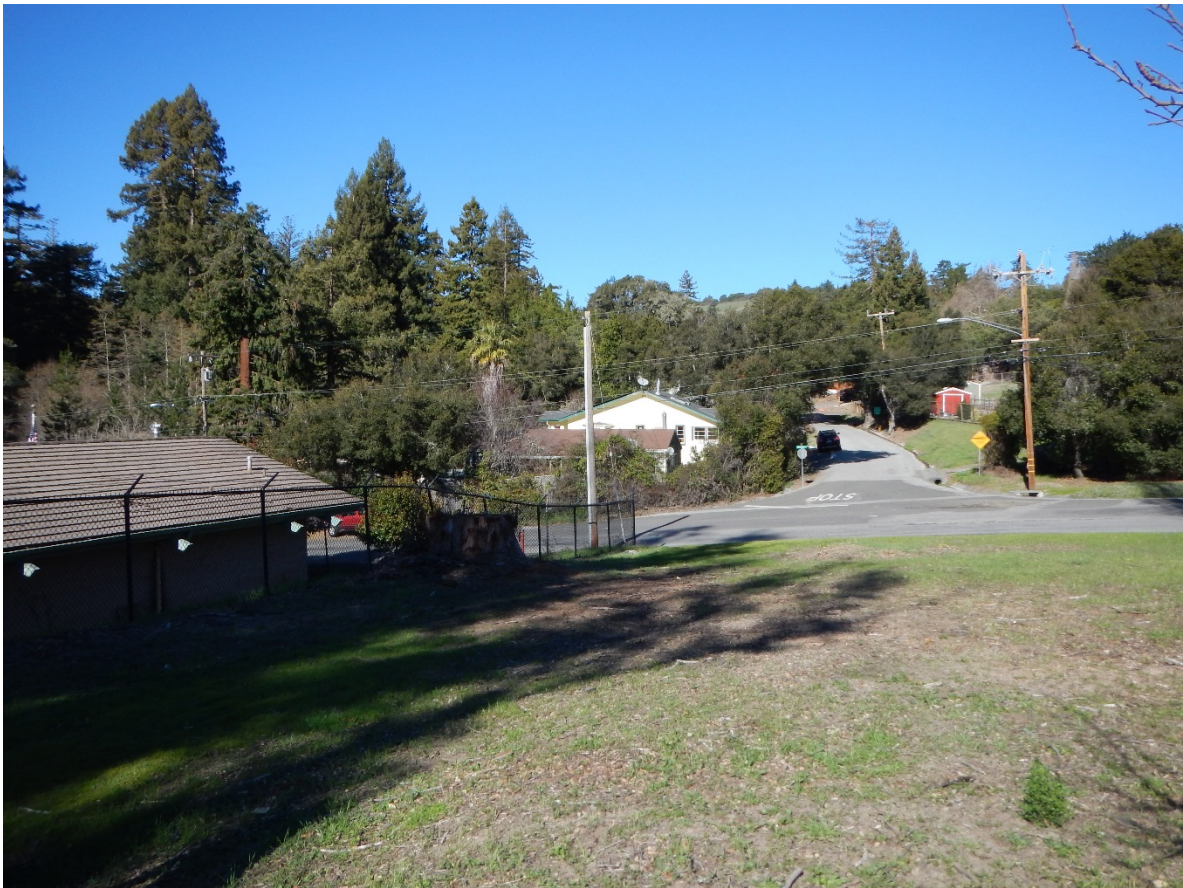
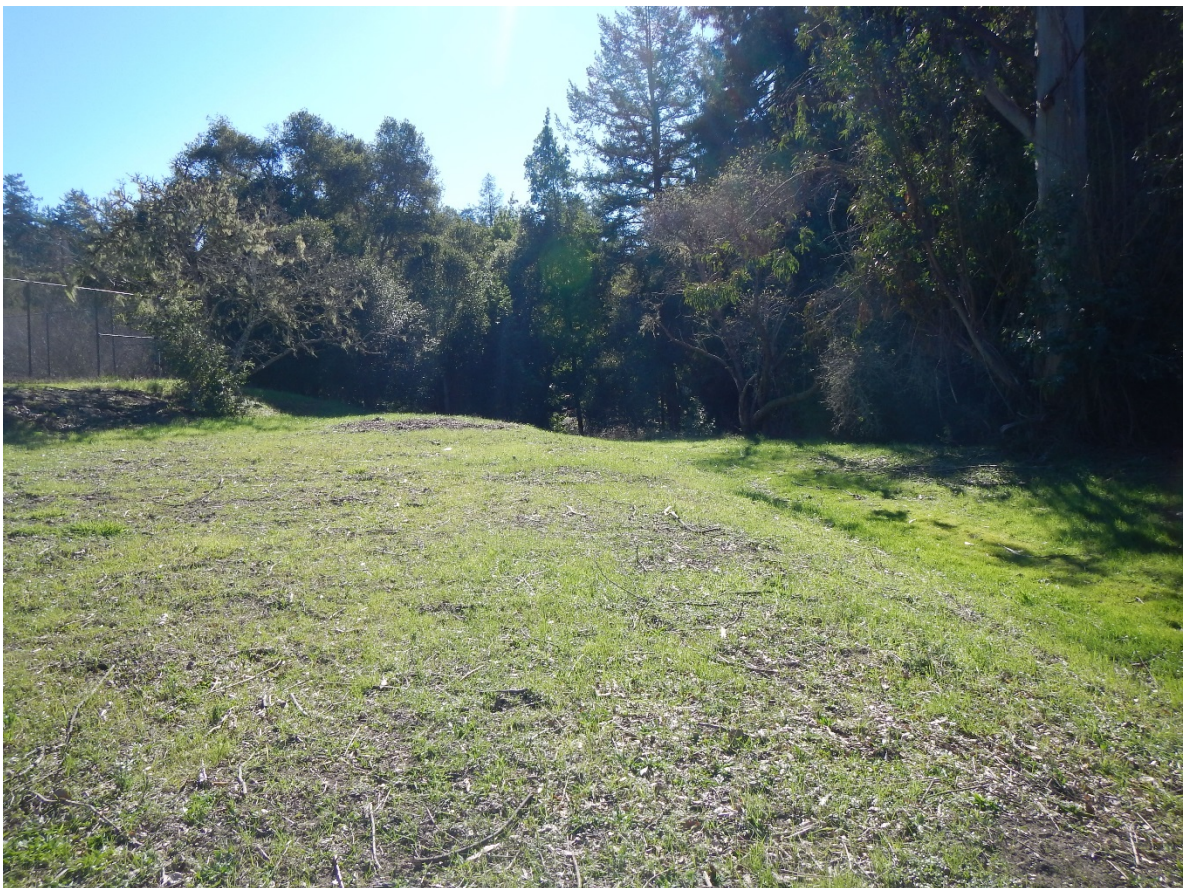
Figure 4. Site East of San Mateo County Yard, Entrada Way

- The vacant lot immediately east of the San Mateo County yard (the yard address is 59 Entrada, La Honda, CA (Figure 4);
- The Memory Lane location (Figure 5);
- The Glenwood Boys Camp site (Figure 6); and,
- The San Mateo County Yard site on Entrada (Figure 7).
